Proposed Plan  
 1:100

project name:  
 Richmond Lock Estate  
 St.Margarets Rd,Twickenham  
 drawing name:  
 Proposed Set (Part 5)  
 Plan & East Elevation  
 Photographic Survey  
 revision: /  
 dwg no: GA05  
 project number:  
 WOW 008

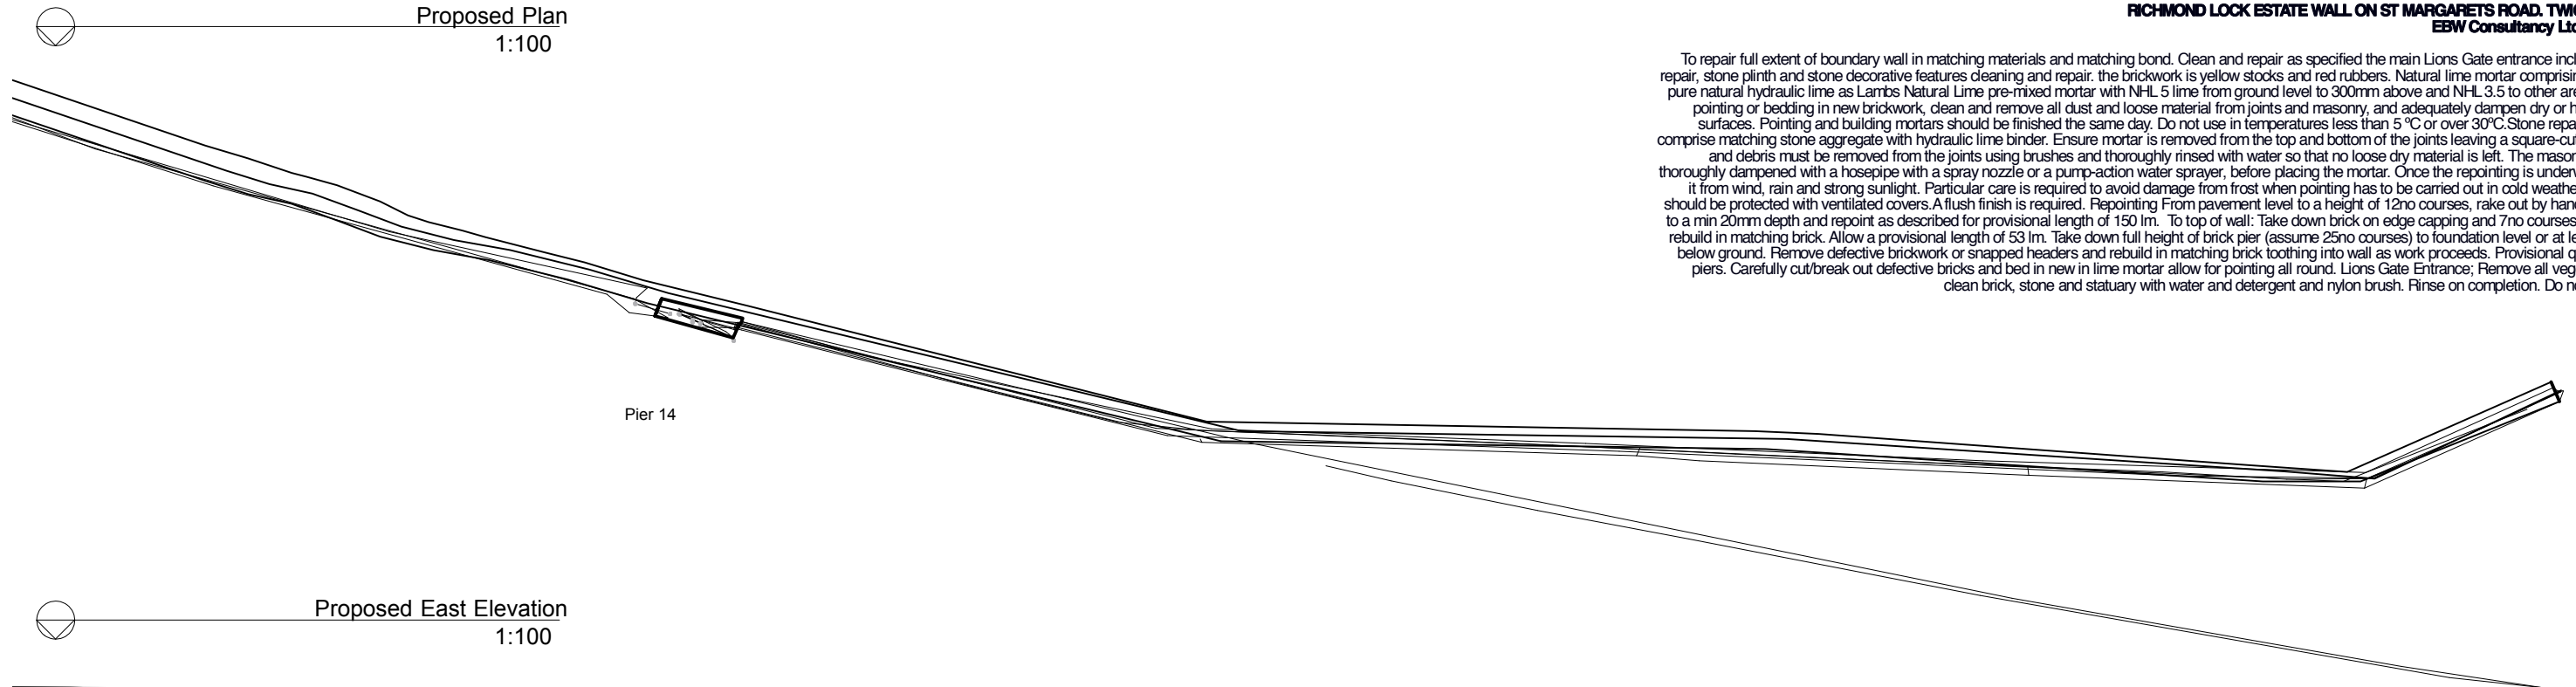
To repair full extent of boundary wall in matching materials and matching bond. Clean and repair as specified the main Lions Gate entrance including brick repair, stone plinth and stone decorative features cleaning and repair. the brickwork is yellow stocks and red rubbers. Natural lime mortar comprising St Astier pure natural hydraulic lime as Lamb's Natural Lime pre-mixed mortar with NHL 5 lime from ground level to 300mm above and NHL 3.5 to other areas. Before pointing or bedding in new brickwork, clean and remove all dust and loose material from joints and masonry, and adequately dampen dry or high suction surfaces. Pointing and building mortars should be finished the same day. Do not use in temperatures less than 5 °C or over 30°C. Stone repair mortar to comprise matching stone aggregate with hydraulic lime binder. Ensure mortar is removed from the top and bottom of the joints leaving a square-cut joint. Dust and debris must be removed from the joints using brushes and thoroughly rinsed with water so that no loose dry material is left. The masonry must be thoroughly dampened with a hosepipe with a spray nozzle or a pump-action water sprayer, before placing the mortar. Once the repointing is underway protect it from wind, rain and strong sunlight. Particular care is required to avoid damage from frost when pointing has to be carried out in cold weather. Surfaces should be protected with ventilated covers. A flush finish is required. Repointing From pavement level to a height of 12no courses, rake out by hand all mortar to a min 20mm depth and repoint as described for provisional length of 150 lm. To top of wall: Take down brick on edge capping and 7no courses below and rebuild in matching brick. Allow a provisional length of 53 lm. Take down full height of brick pier (assume 25no courses) to foundation level or at least 450mm below ground. Remove defective brickwork or snapped headers and rebuild in matching brick toothing into wall as work proceeds. Provisional quantity 3no piers. Carefully cut/break out defective bricks and bed in new in lime mortar allow for pointing all round. Lions Gate Entrance; Remove all vegetation and clean brick, stone and statuary with water and detergent and nylon brush. Rinse on completion. Do not saturate.

dimensions:  
 The wall is in a potentially dangerous condition as piers are broken, stretchers have split and much pointing has come away and the wall is overhanging the public highway. Works are required urgently to mitigate risk of collapse. WOW were appointed for partial services for planning / LBC and not appointed as designers or structural surveyors nor CDM nor did their remit extend to instruction of work. EBW Consultancy Ltd have made the proposal and are the responsible party for instructing the works. This drawing has been prepared from a survey that was for LISTED BUILDING CONSENT PURPOSES ONLY, which is diagrammatic. No access was proved to the majority of the rear of the wall. So while this drawing can be used as a base drawing for general arrangement, it should not be used for construction. As a result, no warranty as to be precision of the dimensions or can be given.
