Arboricultural Impact Assessment

34 Nassau Road SW13 9QE

Report Reference Number: 240624-2.0-34NR-AIA-AN

Project Name: 34 Nassau Road SW13 9QE
Report Ref: 240624-2.0-34NR-AIA-AN
Report Title: Arboricultural Impact Assessment

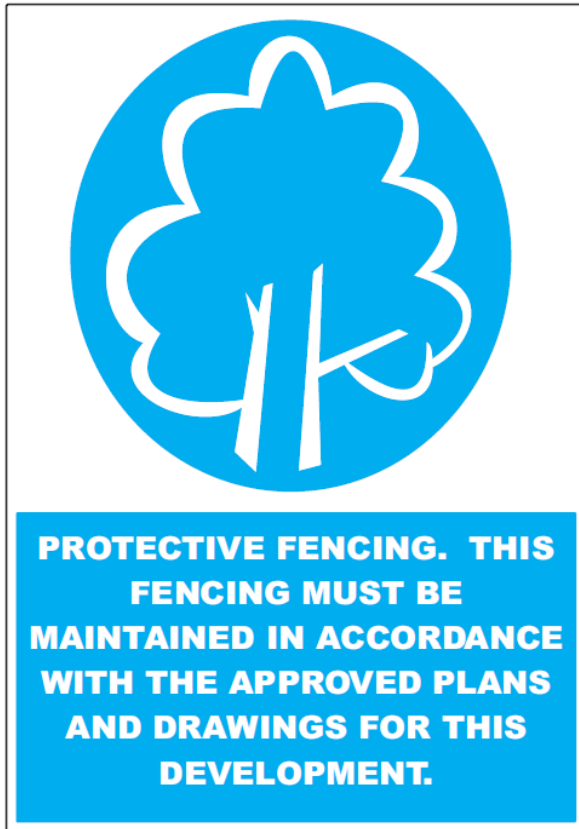
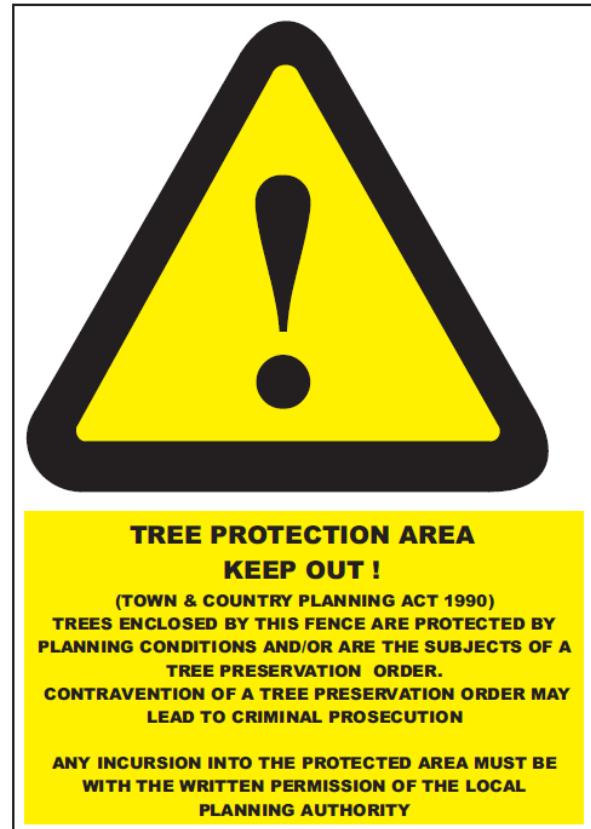
Tree Protection Fencing Sign

- The CEZ will be clearly identified (see construction exclusion zone sign example below)

3.3.3 All protection fencing should carry identifying signs that state its purpose and proscribe its removal until all demolition and construction work is complete. An example sign is given at Appendix C.
