Arboricultural Impact Assessment Method Statement & Tree Protection Plan (to BS:5837 2012)

32 Broad Lane, Hampton
TW12 3AZ

Date: 9th May 2024

Ref: TH 4611

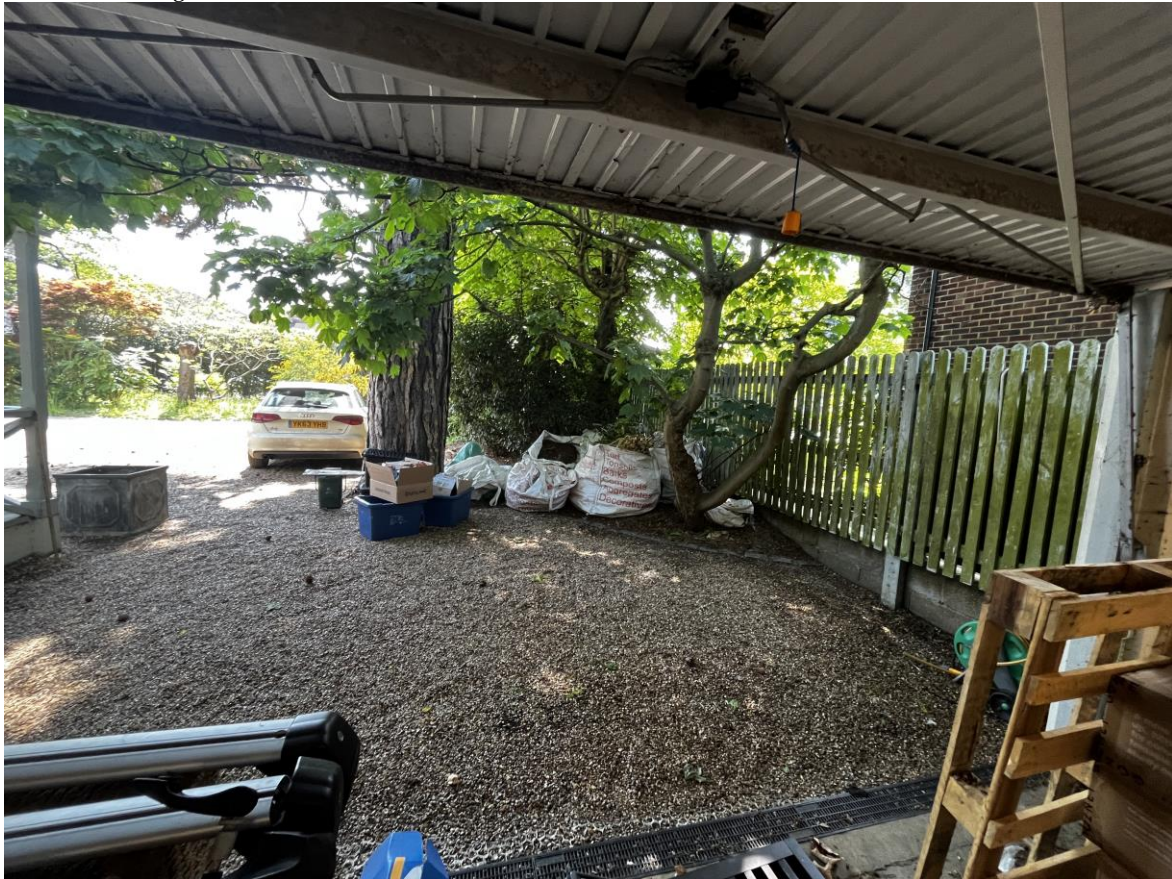
Photo 1. Looking south at the base of Pine T6

9.3.3 To further minimise this risk, the stems of Pine T6 and Tulip Tree (T7) will be boxed in with wooden plyboards.

2. Erect protective fencing along the position(s) shown by the dashed red line/s on the TPP.
3. Protect stems of Pine and Tulip Tree from damage by boxing off with wooden ply boards.

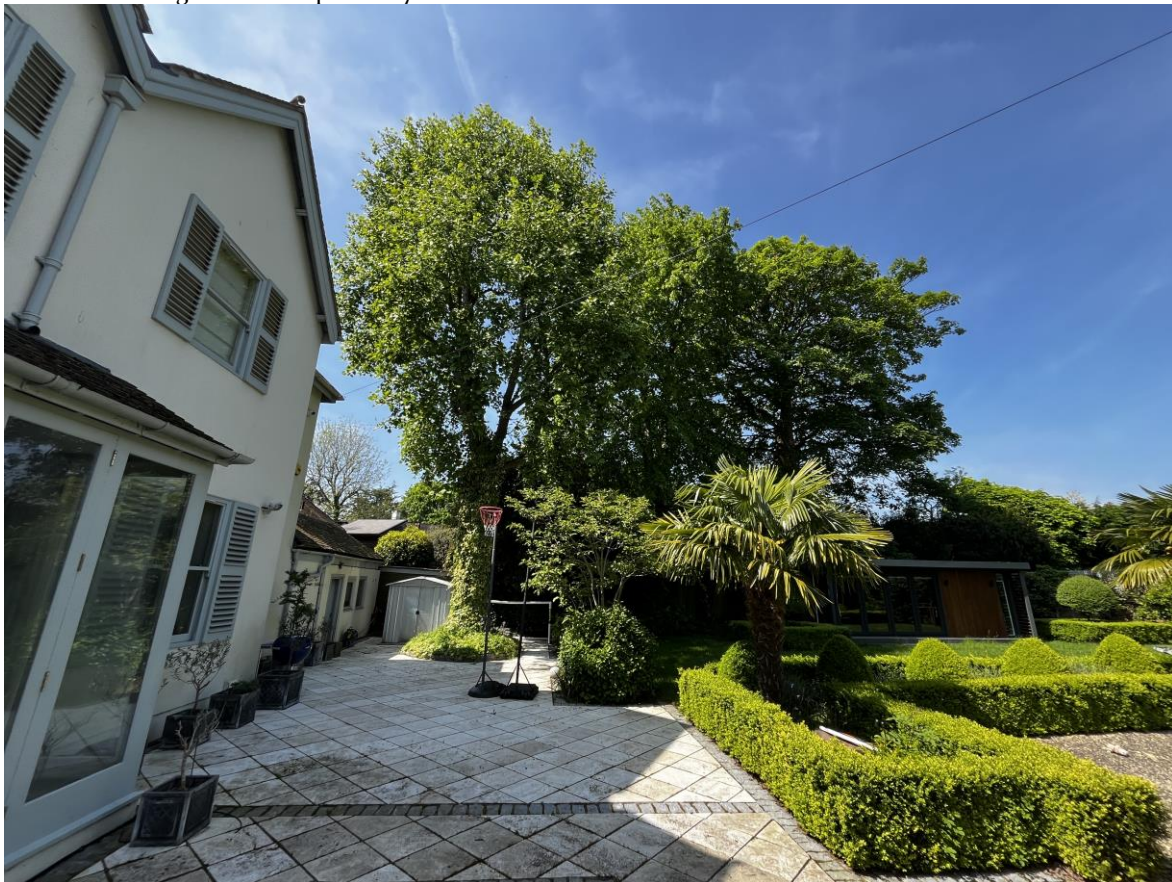
9.5.3 The existing hard surface of the rear patio (see photo 2) will provide ample protection for any roots growing beneath and so does not need reinforcing.

Photo 2. Looking west at Tulip Tree T7

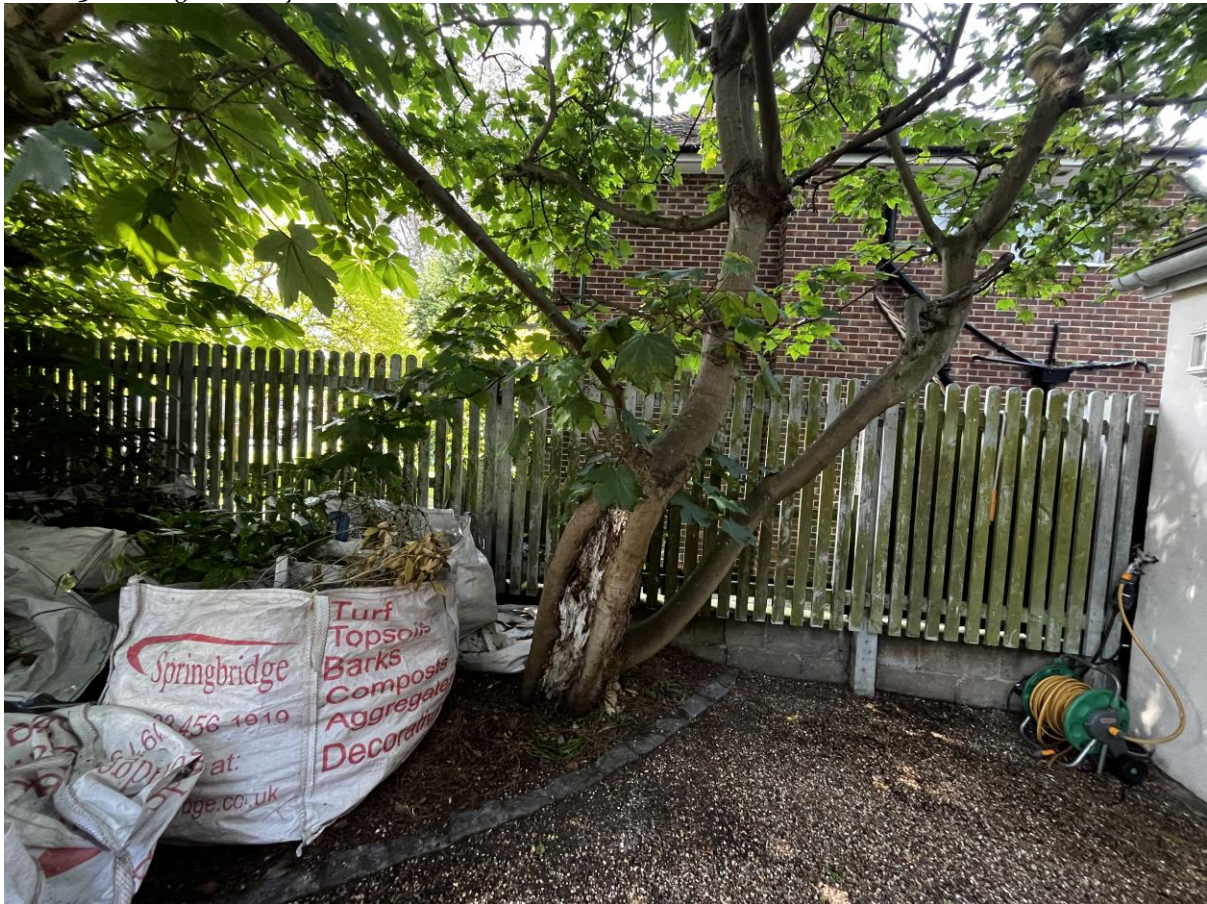
9.6.1 The lower lateral branches of Sycamore T2 are potentially vulnerable to damage during demolition and construction. The tree is in a poor structural condition (see photo 3), but the applicant wishes to retain it for screening.

Photo 3. Looking west at Sycamore T2

9.6.2 To reduce the risk of accidental damage to acceptable levels, the lateral branches on the vulnerable side of the crown will be tip-reduced and crown lifted to improve clearance (see appendix 2 for more specific details).

9.8.3 The proposed pruning is minor, targeted and will not affect the health or appearance of the tree.

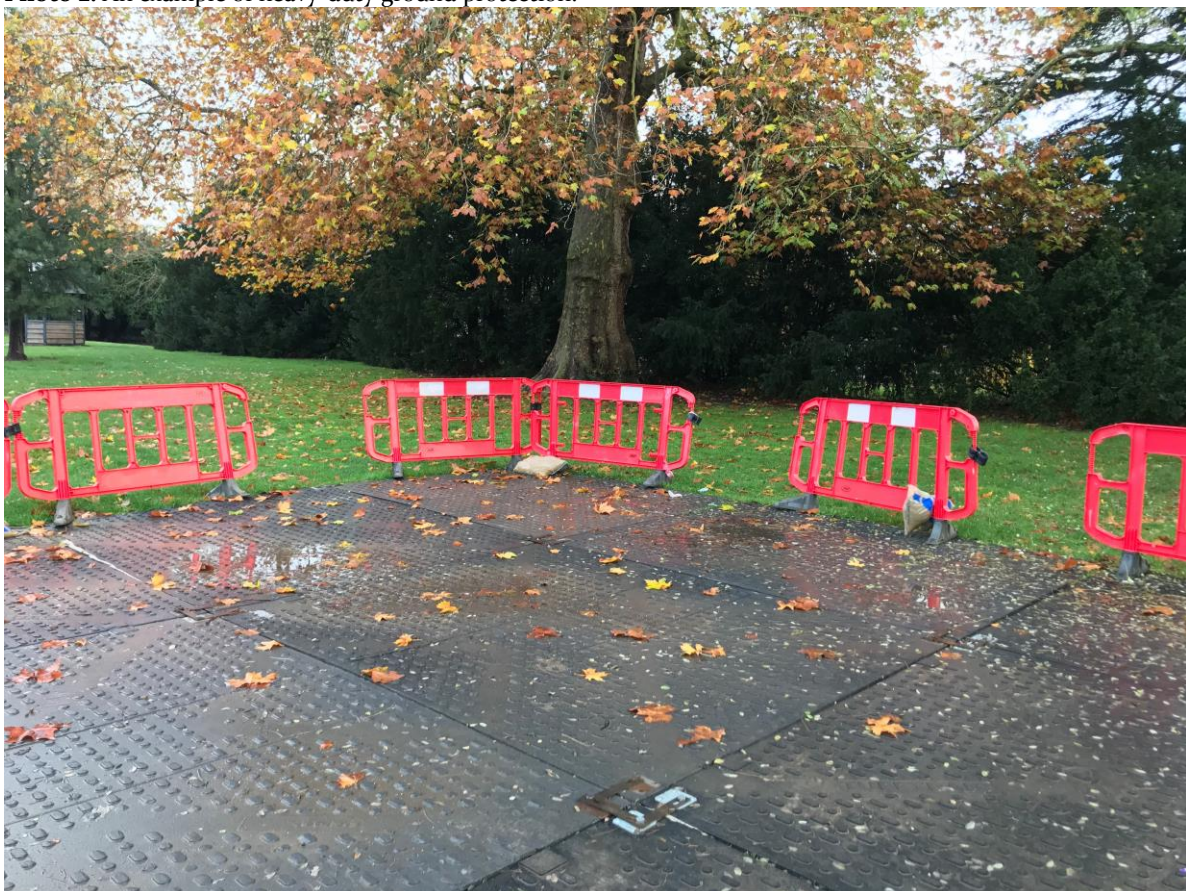
Photo 2. An example of heavy-duty ground protection.
