ELITE DESIGNERS LTD
 16 ST PETERS ROAD
 TERRACE VAULTS AND
 CONSERVATORY E.A. PCMS

2022-065 SK/100 07/24 Rev A
 VISUAL INSPECTION 7/4/2024

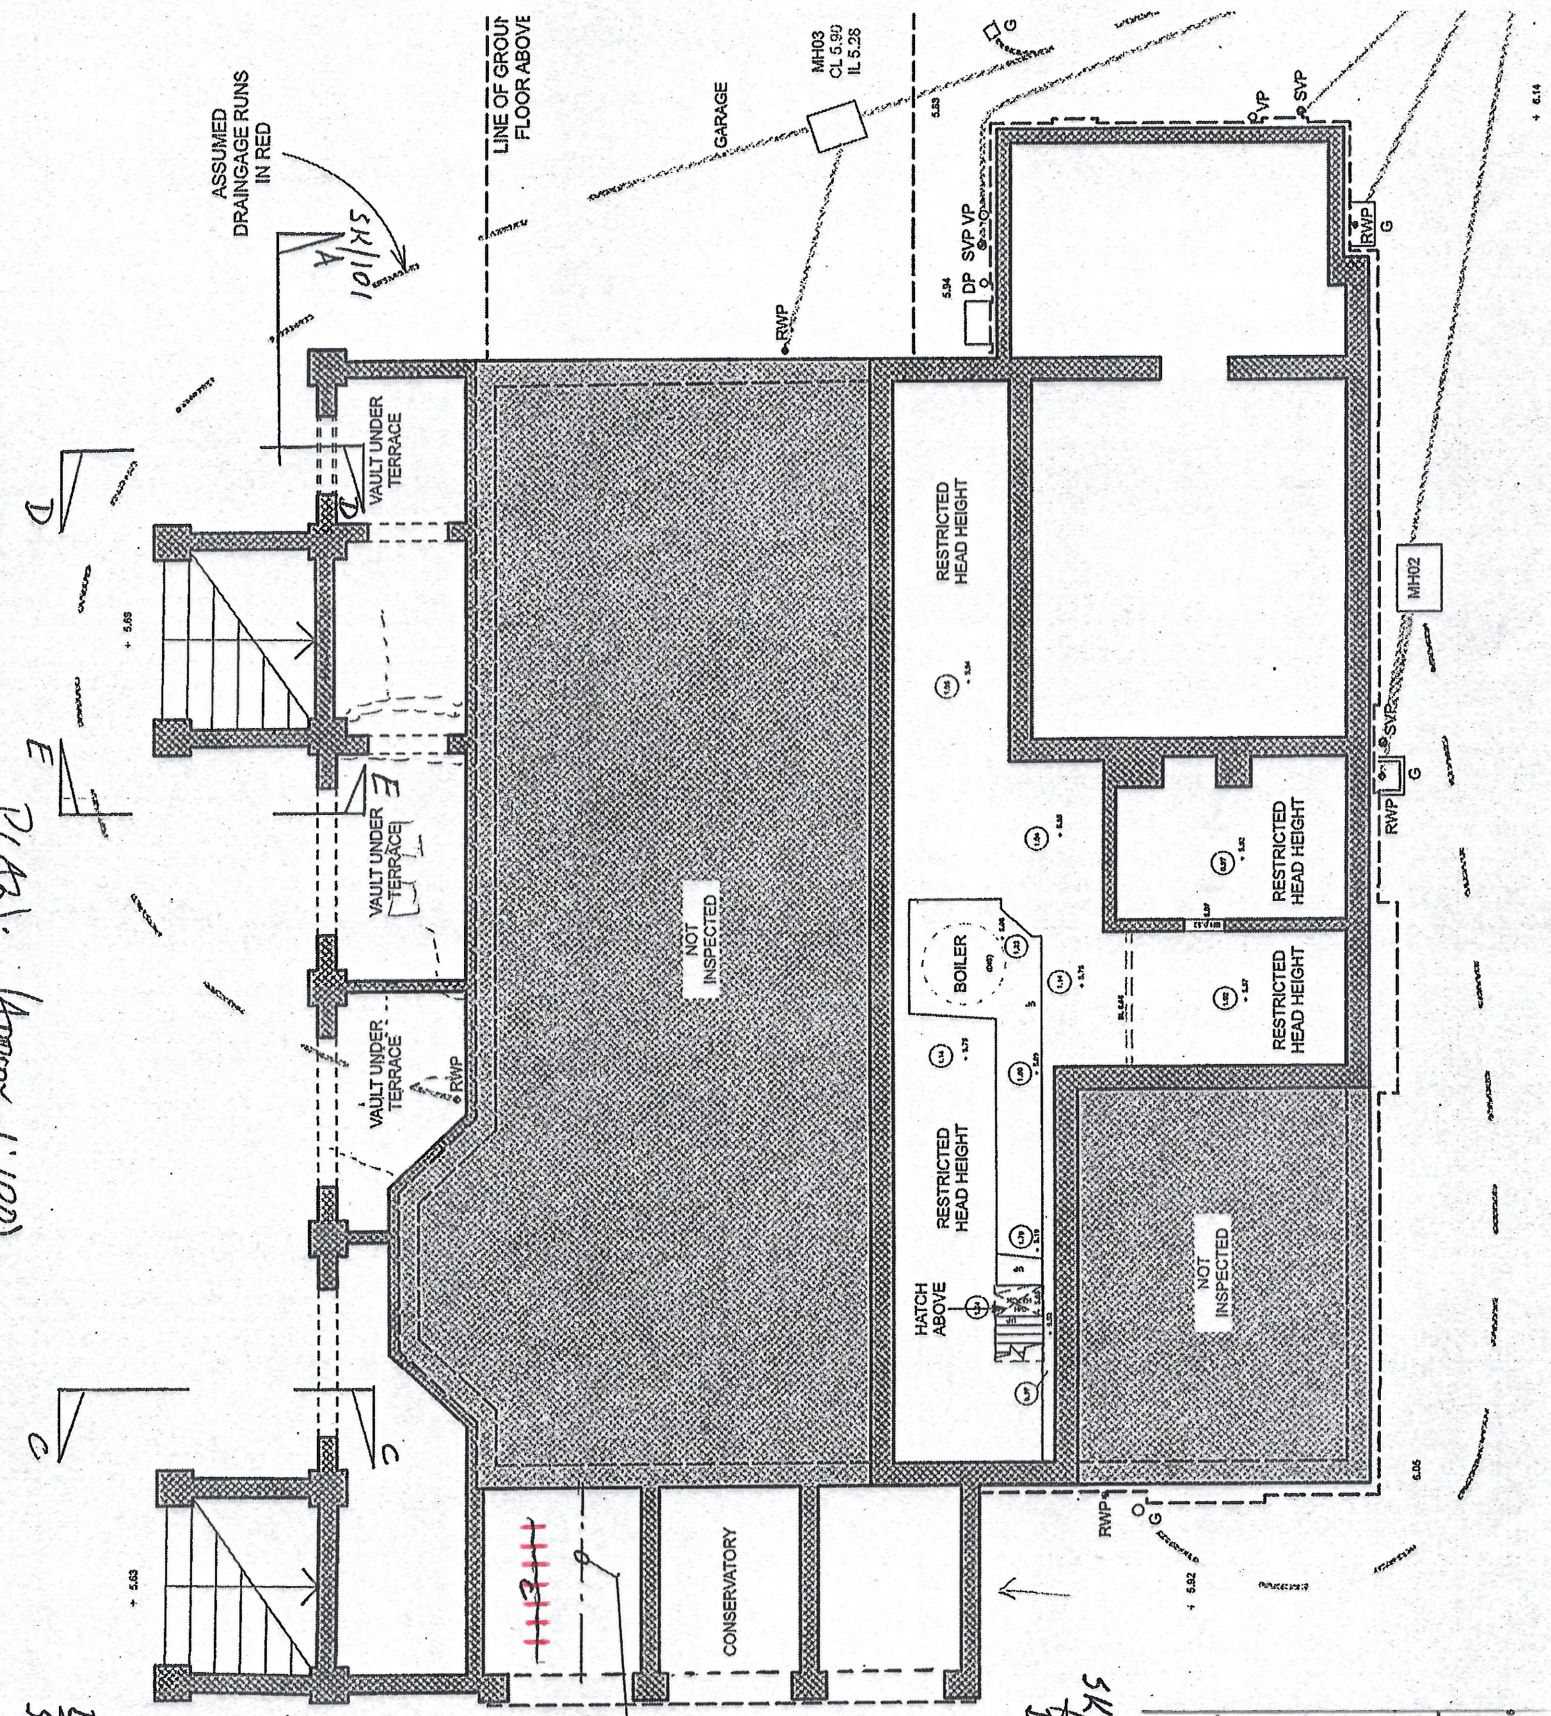
PLANS: (Approx 1:100)
 AT GARDEN LEVEL.

① - ⑦
 STEEL BEAM
 CRACKED CONCRETE

CORRODED STEEL BEAM EXPOSED
 IN UNDERSIDE OF SLAB, OVER
 PROPOSED REPAIRS TO SLAB

CRACK IN TILED FLOOR OF
 CONSERVATORY ABOVE IRREGULAR
 'CRACK' IN UNDERSIDE OF SLAB, OVER

NO 5.5 HELIBARS 400LIVE,
 AT 250% SET IN SAND-OUT
 GROOVES 40mm DEEP INTO TOP
 OF CONCRETE. CRACK ALSO
 TO BE REPAIR-INSPECTED.
 REFER TO SK/200 FOR
 SCHEDULE OF PROPOSED REPAIRS.
