# ENTRANCE HALL TILING DAMAGE SURVEY

Rev A Scale altered Nov 24  
**16 St. Peters Road**  
 Title: Entrance Hall Damage Survey  
 Drawing No: 0122823-Su20A Scale 1:25 @ A3

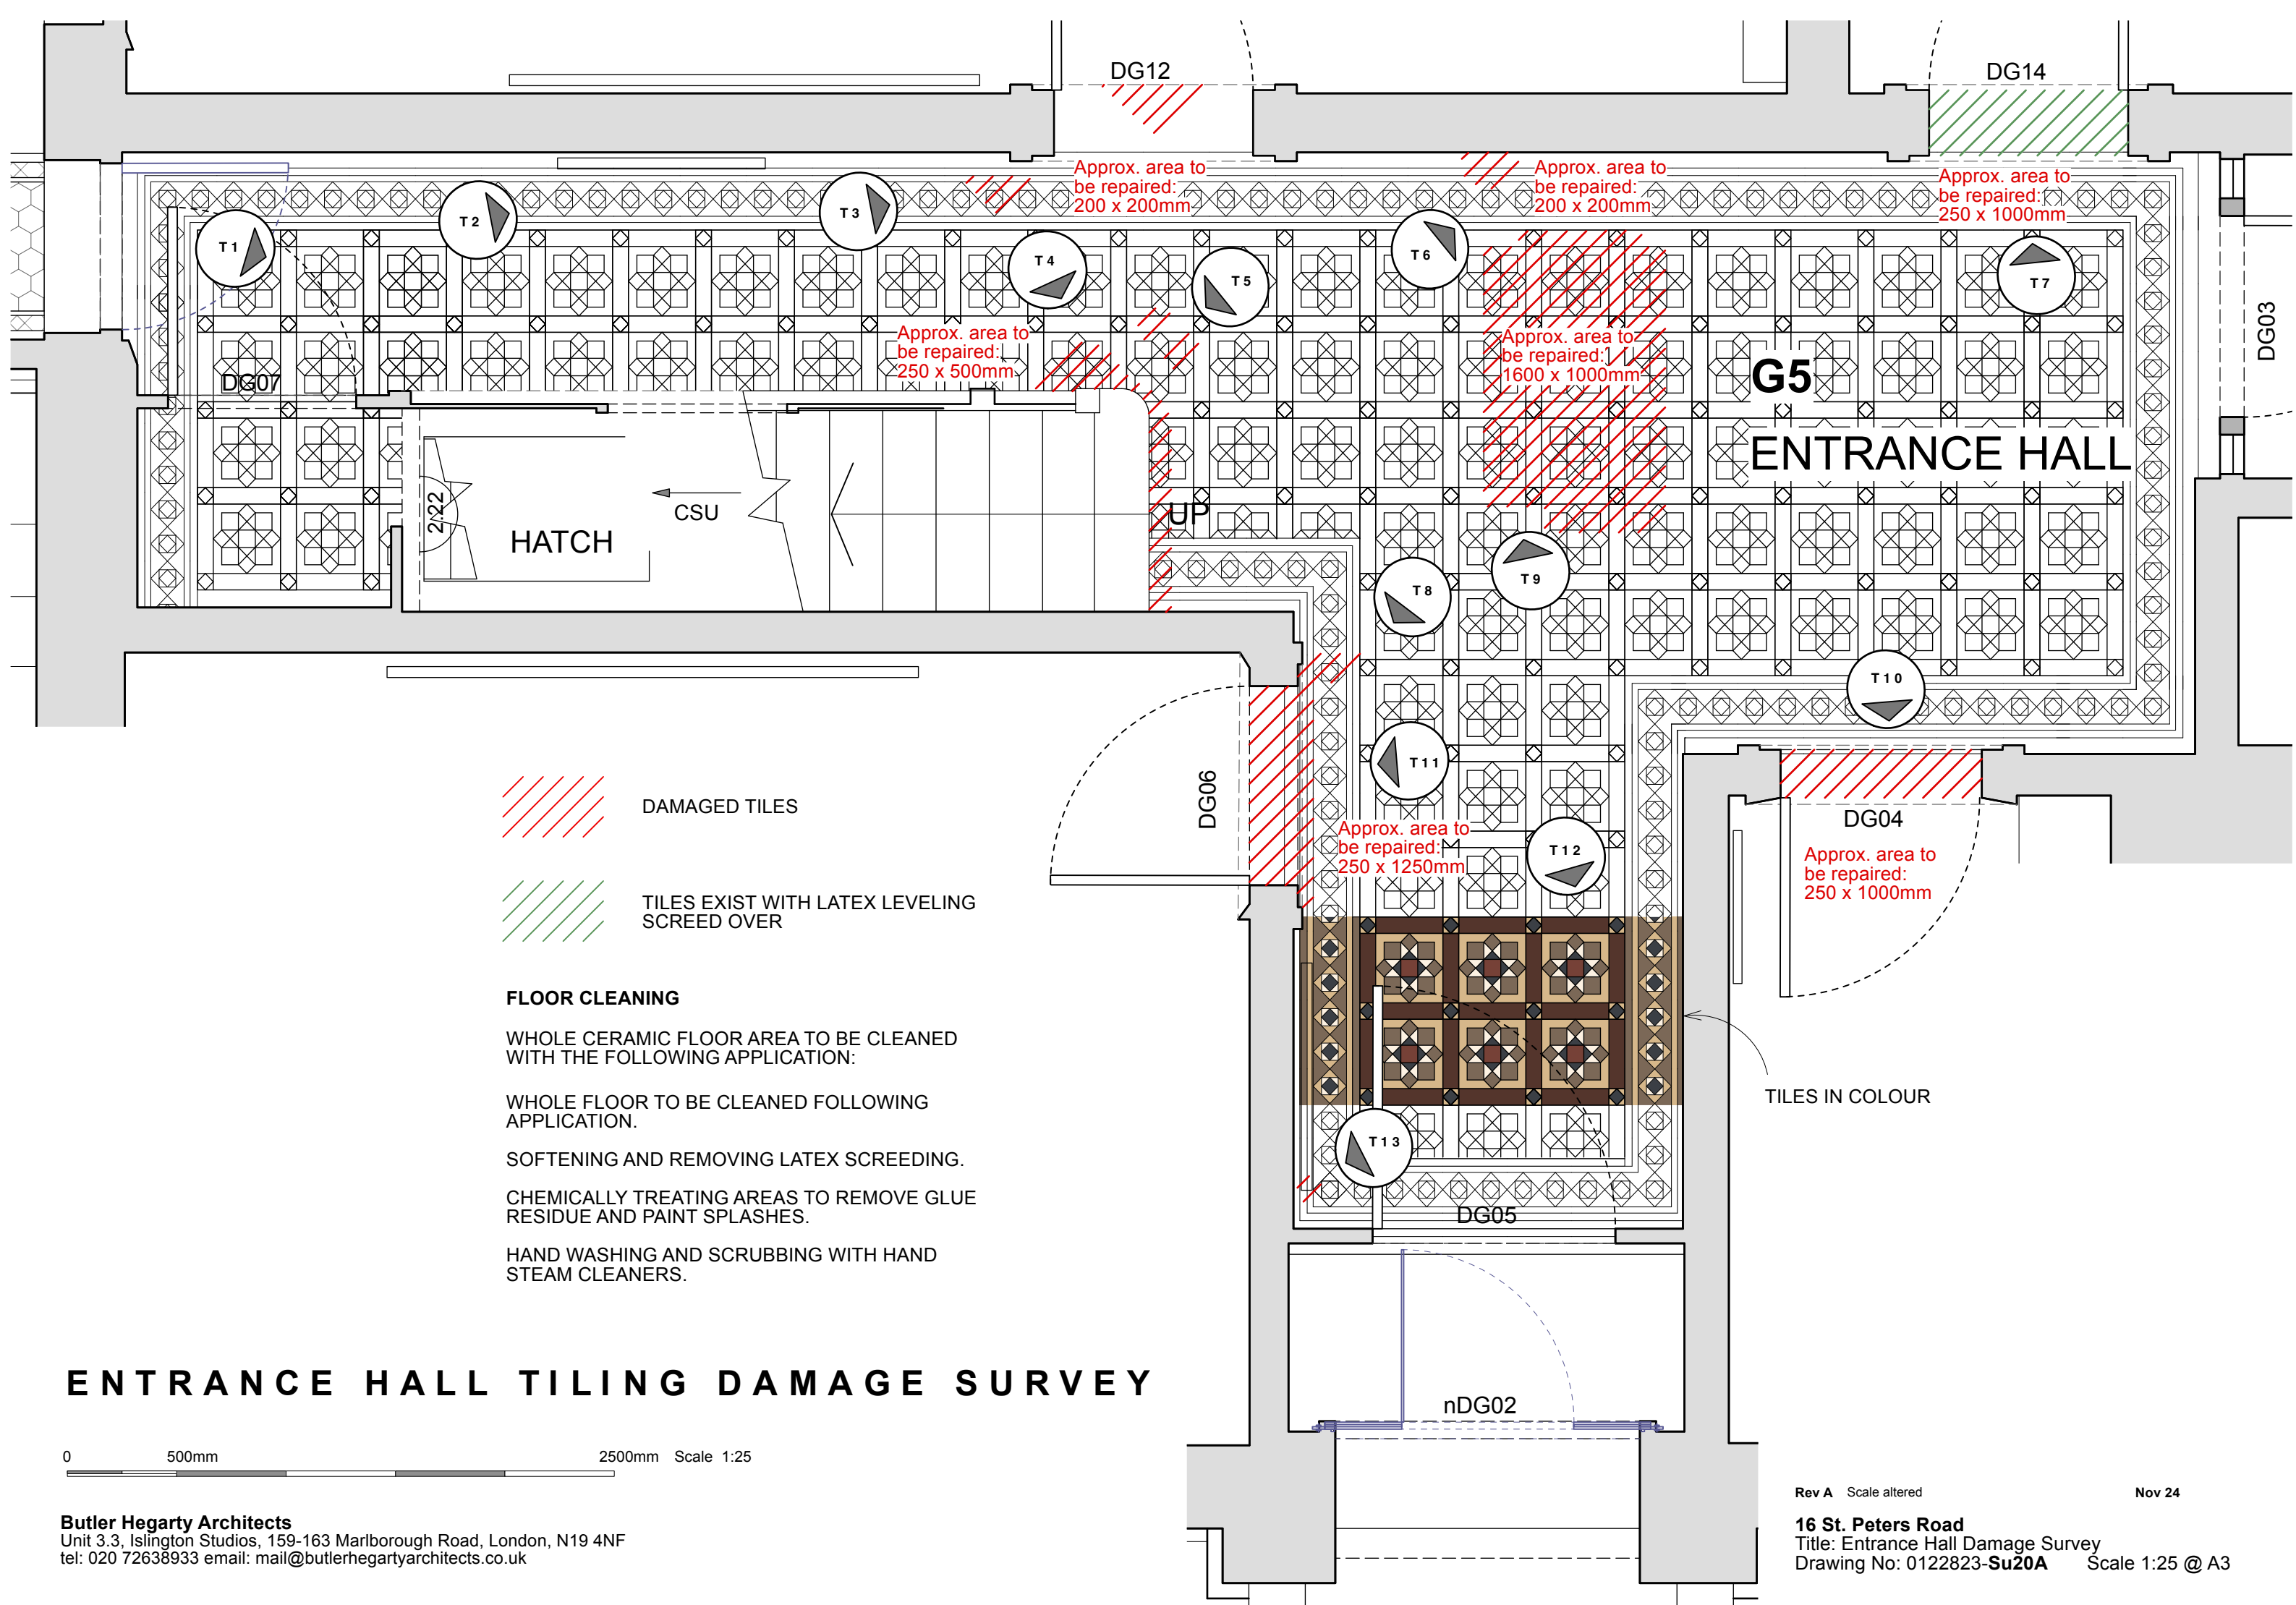
DAMAGED TILES

TILES EXIST WITH LATEX LEVELING SCREED OVER

**FLOOR CLEANING**

WHOLE CERAMIC FLOOR AREA TO BE CLEANED WITH THE FOLLOWING APPLICATION:

WHOLE FLOOR TO BE CLEANED FOLLOWING APPLICATION.

SOFTENING AND REMOVING LATEX SCREEDING.

CHEMICALLY TREATING AREAS TO REMOVE GLUE RESIDUE AND PAINT SPLASHES.

HAND WASHING AND SCRUBBING WITH HAND STEAM CLEANERS.
