Arboricultural Consultant's Site Supervision & Monitoring Record: 06.01.25

5. Site Supervision & Monitoring Meeting; 6 January 2025

This site supervision meeting was to verify that corrective actions had been completed.

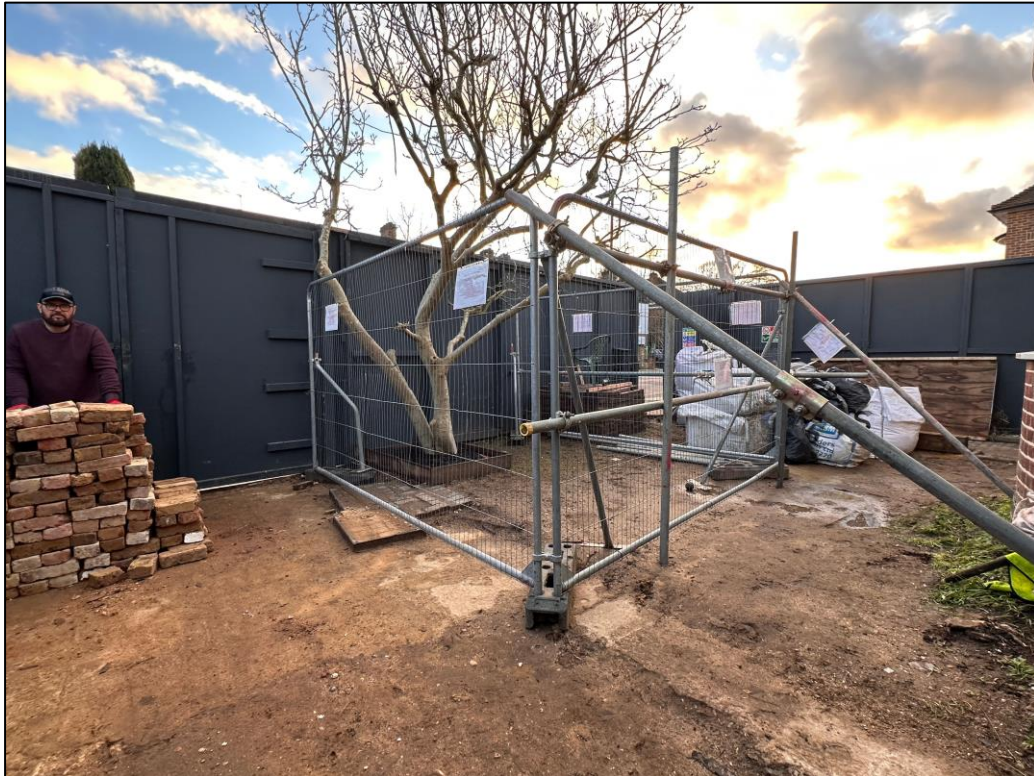
Photo 1.

1. Ref. SSMR_18 Dec 2024 section: 5.4.2.1.

A tree protection barrier (TPB) should be constructed to prohibit access over the RPA of protected tree T2

This has now been constructed, as shown in Photo 1 below.

Warning signs have been erected.

The temporary protection barrier and signs must be maintained in position at all times and checked on a regular basis by an on-site person designated with that responsibility.

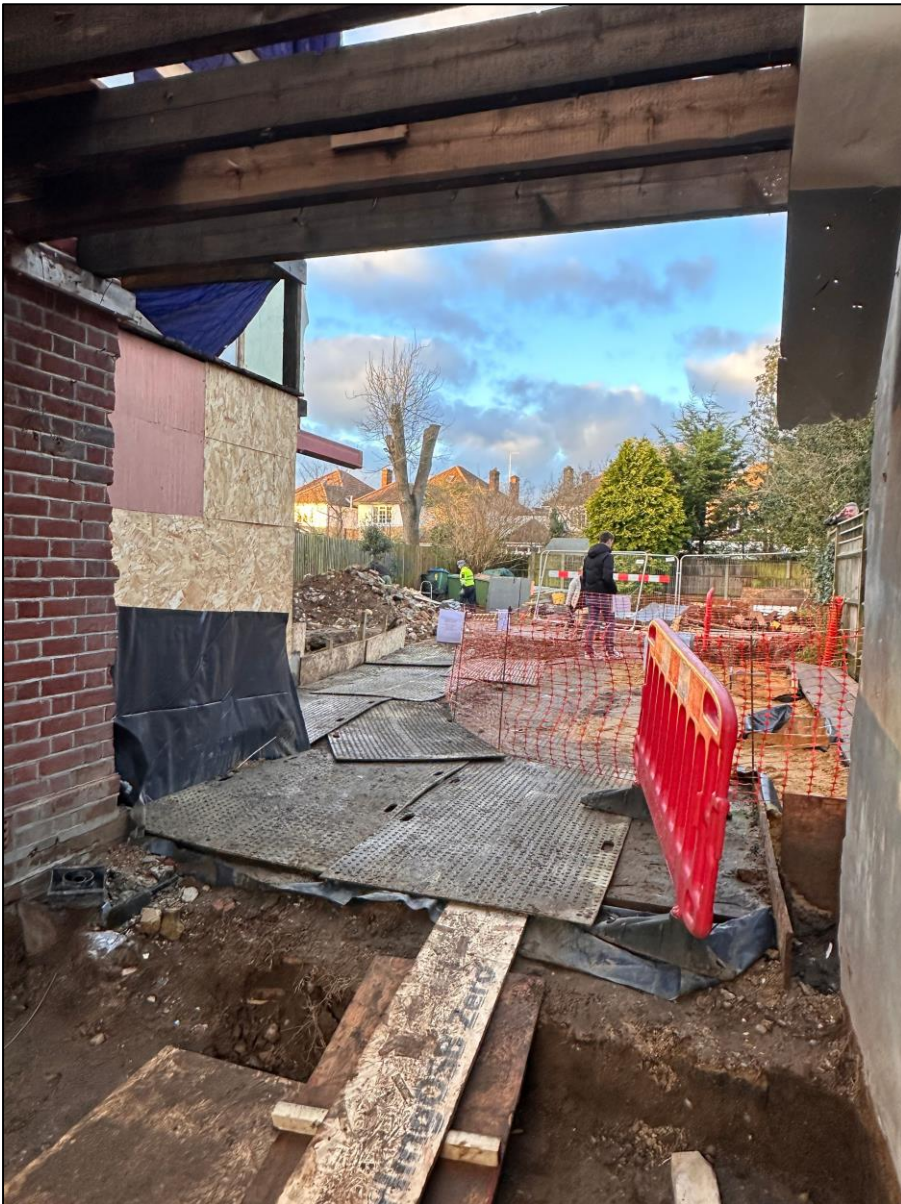
Photo 2.

2. Ref. SSMR_18 Dec 2024 section: 5.4.4.1.

Temporary ground protection must be fully installed over the minimum area of RPA of T1

Temporary ground protection has now been constructed over the RPA of T1, together with a temporary protection barrier (TPB) around the edge of the RPA, to create a construction exclusion zone over the RPA of T1, as shown in Photo 2 below.

The TPB may be moved only to allow site access for the auger rig or digger, but this must be re-erected immediately the rig is in position. The auger rig or digger must be positioned outside the construction exclusion zone at all times during the auger excavation of the piles.

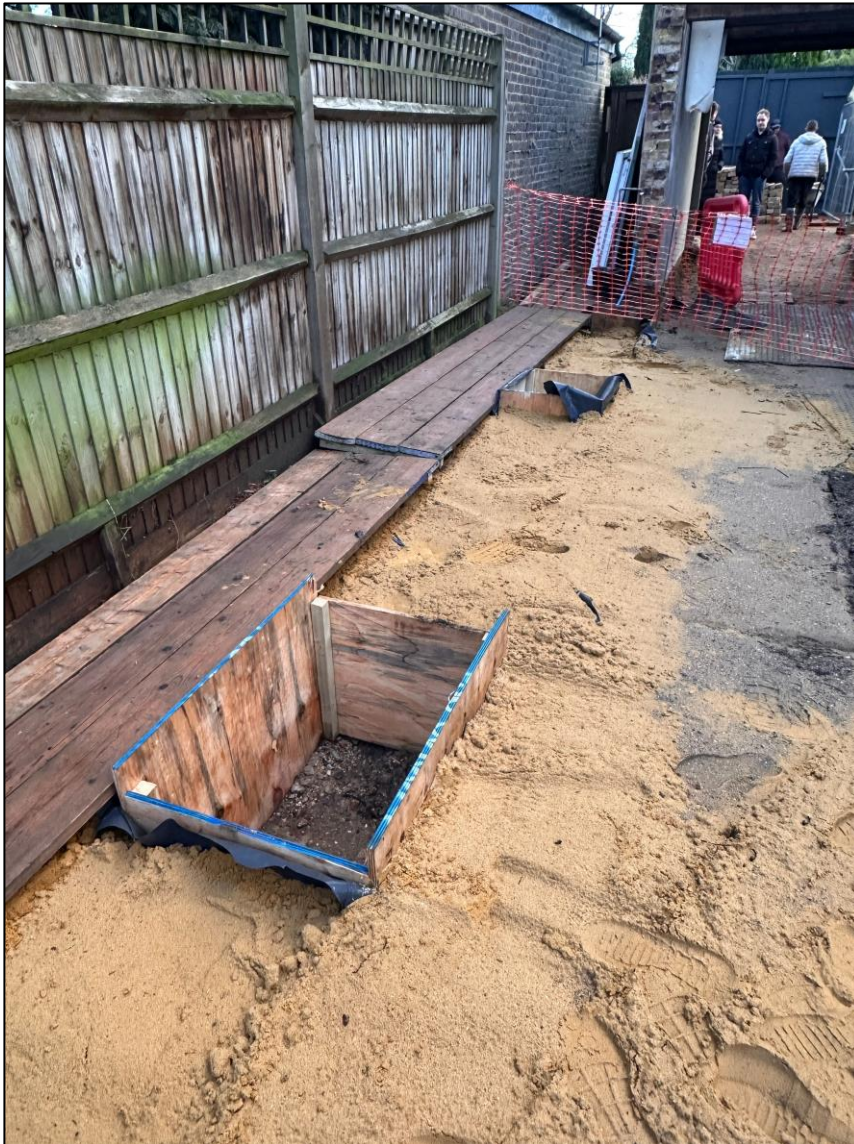
Photo 3.

3. Ref. SSMR_18 Dec 2024 section: 5.4.5.1.

The excavated trench is to be immediately filled with a mixture of topsoil and a proprietary tree and shrub planting compost.

The position of the piles has been identified and these locations will be kept open using a temporary, sunken, wooden box construction.

The board at the edge of the existing area of temporary ground protection sand is to be removed and the temporary ground protection extended across to the retained concrete path:

This remedial work has been completed, as shown in Photo 3 below.
