## WALPOLE'S VILLA STRAWBERRY HILL HOUSE

SOUTH ELEVATION AS APPROVED 06/1626 + 08/3453 & WITH STRIP OUT

DWG NO SHT GA 44

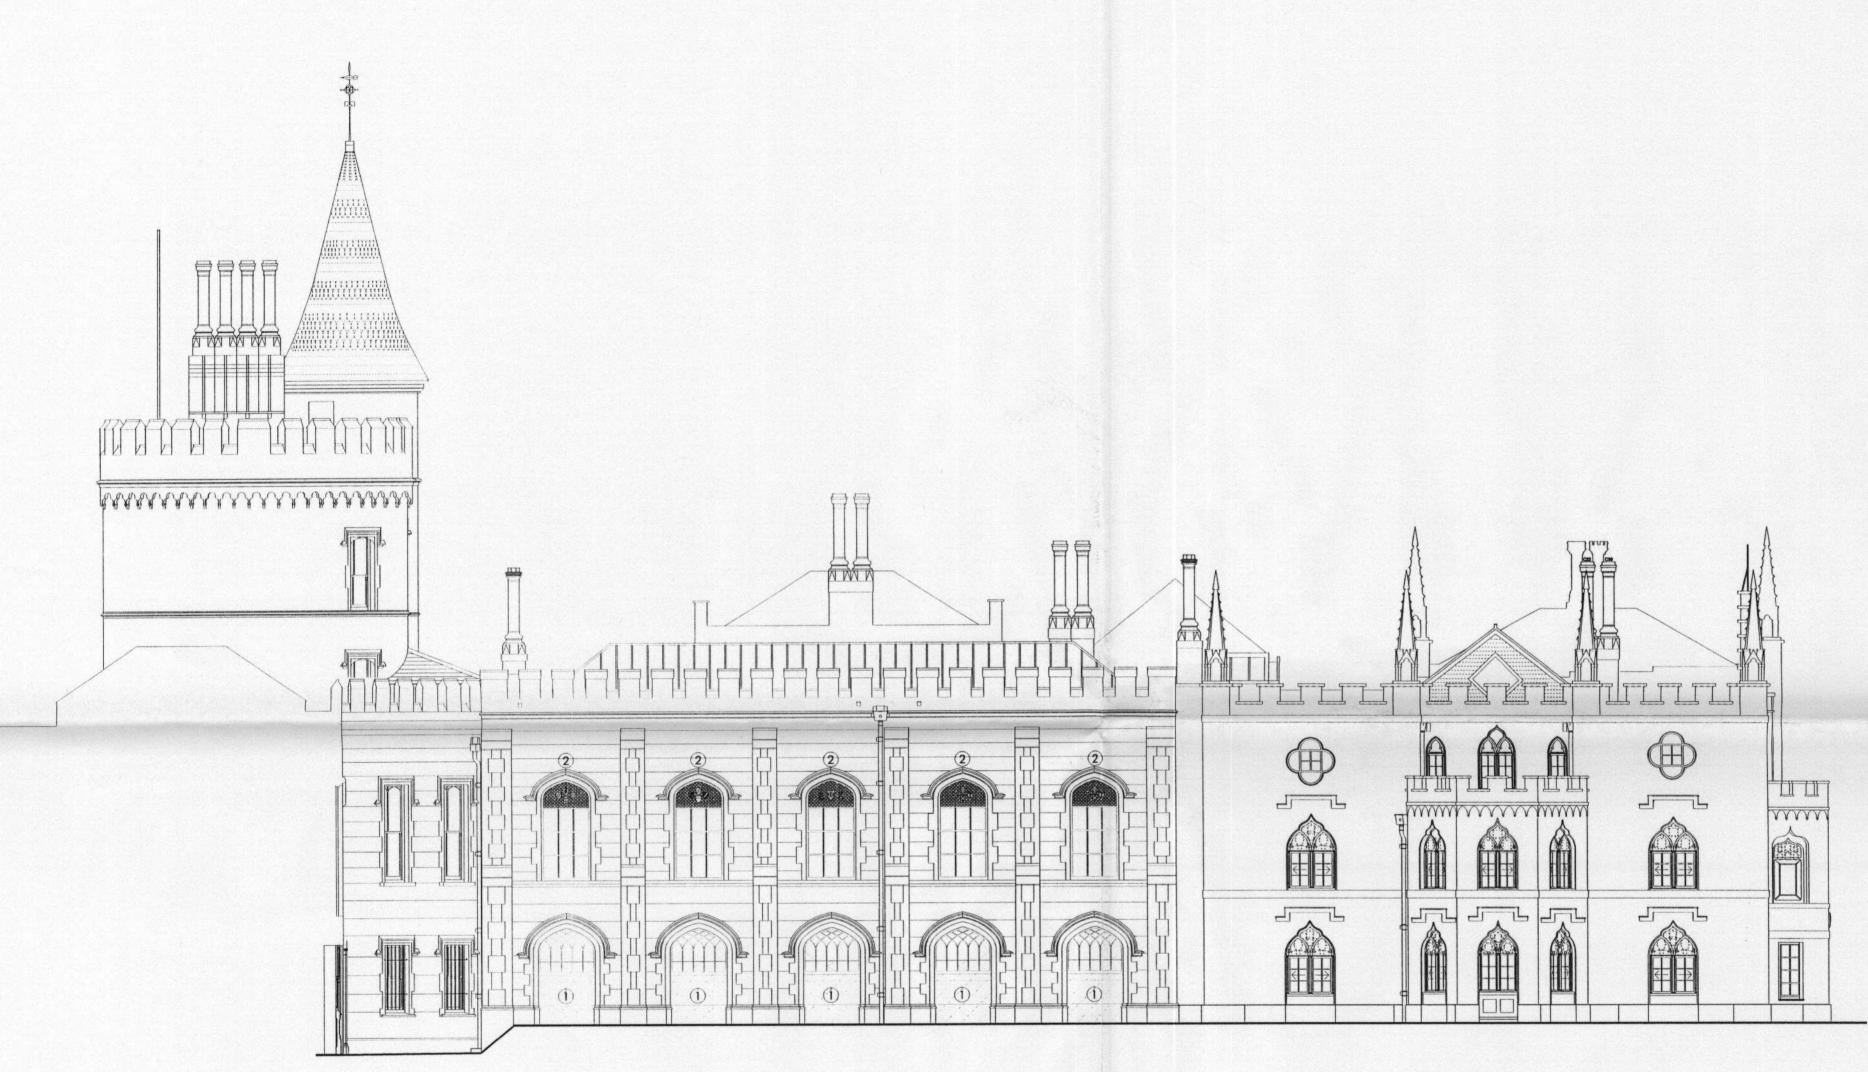
- Dismantle iron windows G8 W1 -5 to store. Remove redundan shutter boxes etc. Remove rendered brickwalling below windows to restore arched openings.
- 2 Dismantle sash window joinery for reduction to original size and configuration based on new evidence.

DISMANTLING REINCORPORATION/STORAGE
