Foul and Surface Water Drainage Strategy Report

Victoria House, 2 – 4 Ennerdale Road, Kew Gardens, Richmond, Surrey TW9 3PG

Reference **C3247**

Date **11th November 2024**

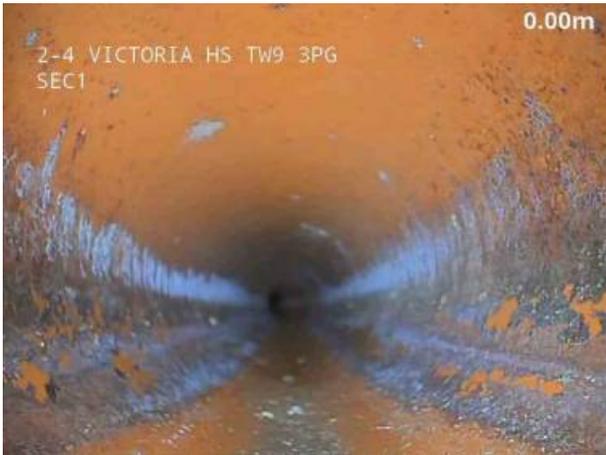
1, 00:00:00, 0.00 m
Water level, 0% of the vertical dimension

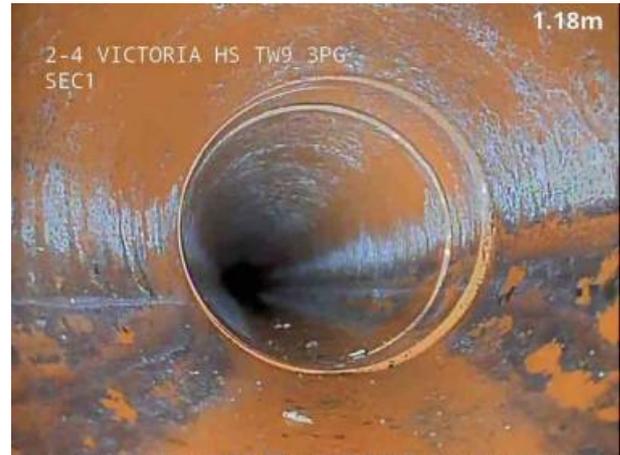
2, 00:00:13, 1.25 m
Line deviates left

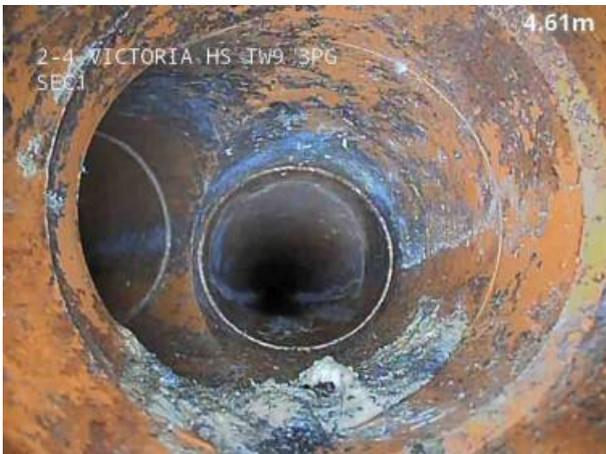
3, 00:00:30, 4.80 m
Junction at 9 o'clock, 100mm dia

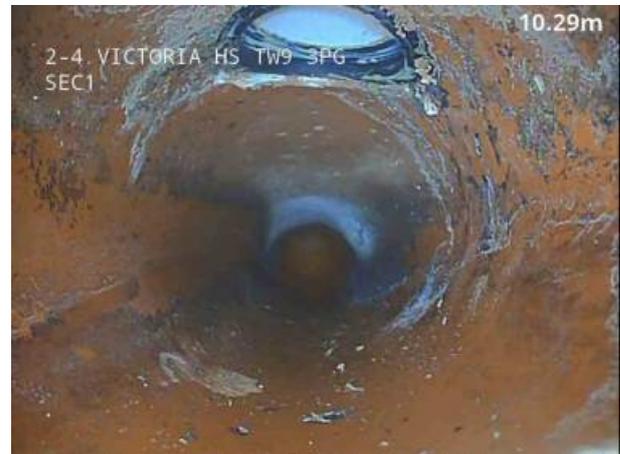
4, 00:01:00, 10.50 m
Junction at 12 o'clock, 40mm dia

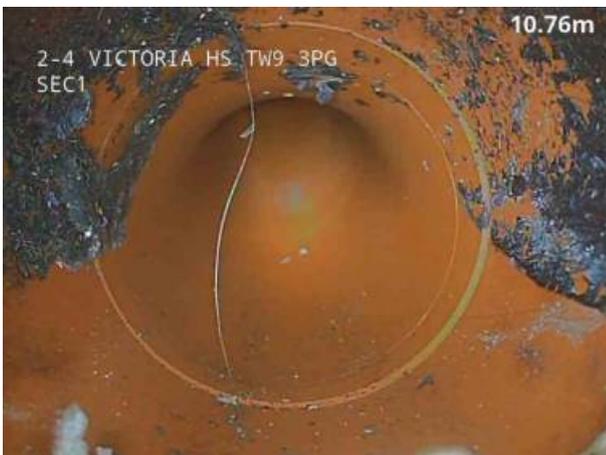
5, 00:01:15, 10.90 m
Line deviates up

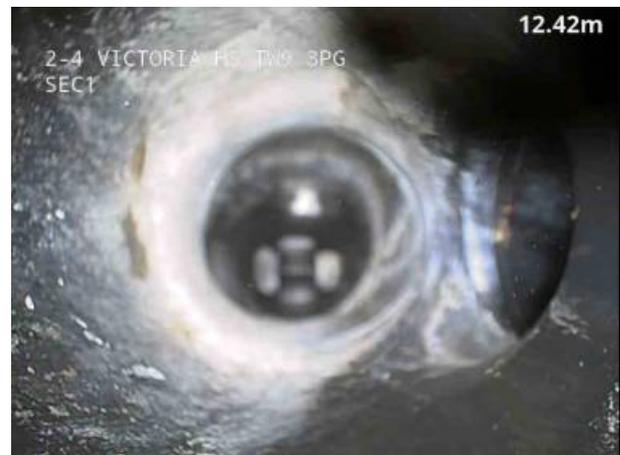
6, 00:01:48, 12.50 m
Junction at 3 o'clock, 100mm dia

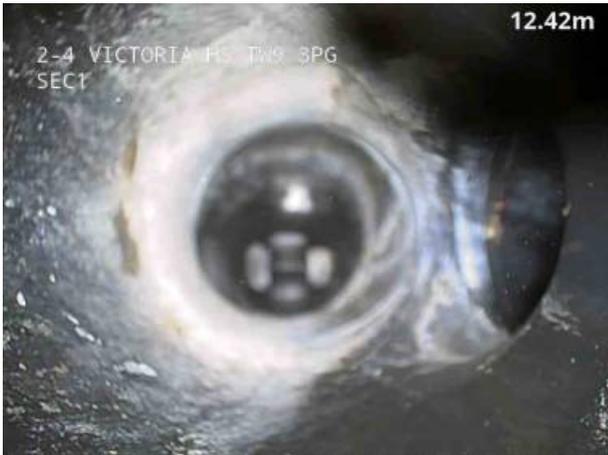
7, 00:01:48, 12.60 m
Finish node, manhole, reference: FP1

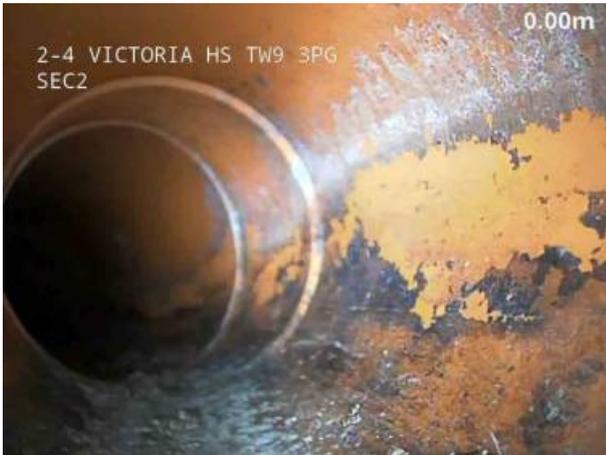
1, 0.00 m
Water level, 0% of the vertical dimension

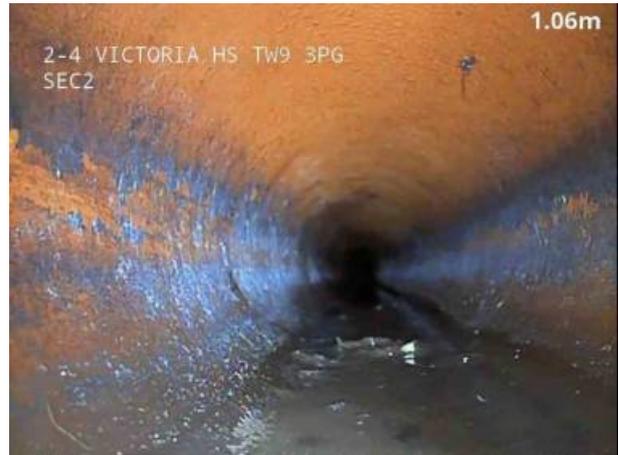
2, 00:00:13, 1.20 m
Water level, 10% of the vertical dimension

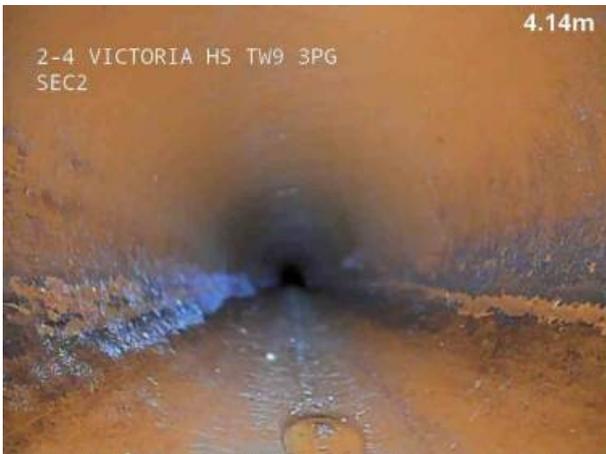
3, 00:00:27, 4.14 m
Water level, 0% of the vertical dimension

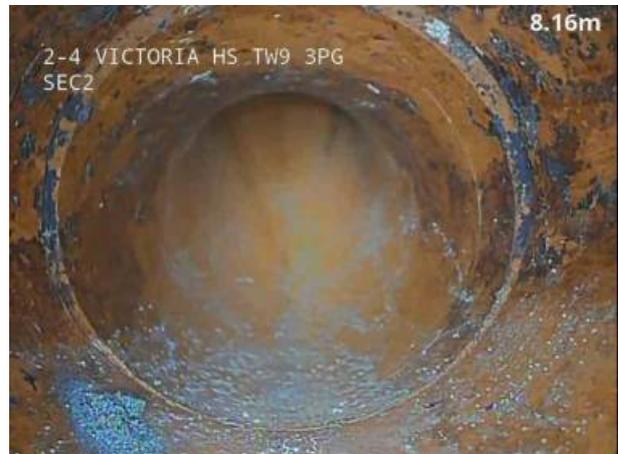
4, 00:00:46, 8.30 m
Line deviates up

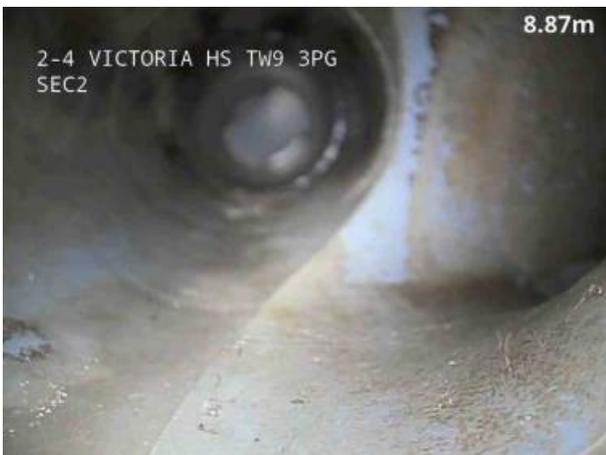
5, 00:00:58, 8.95 m
Junction at 3 o'clock, 100mm dia

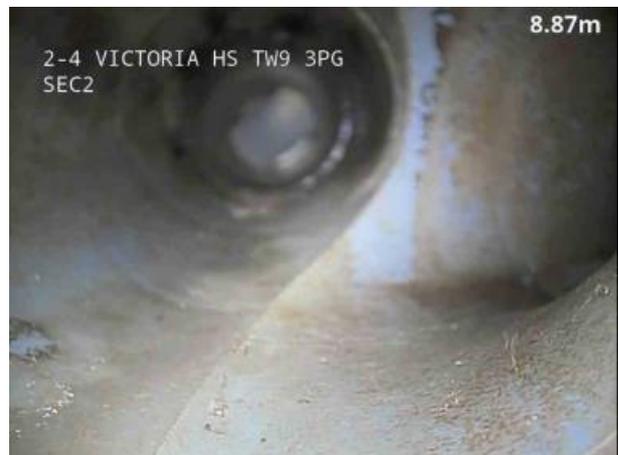
6, 00:01:02, 9.20 m
Finish node, manhole, reference: FP2

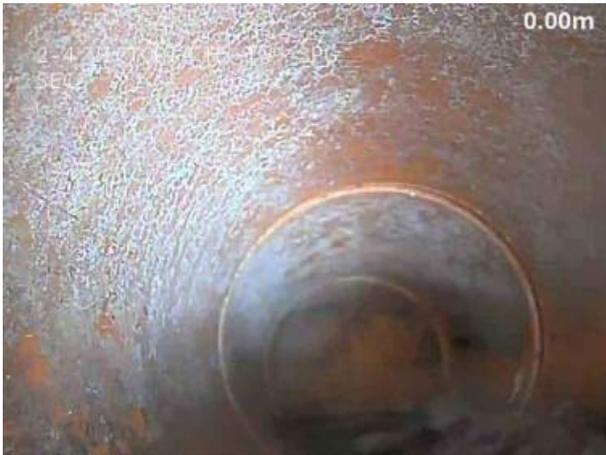
1, 00:00:01, 0.00 m
Water level, 0% of the vertical dimension

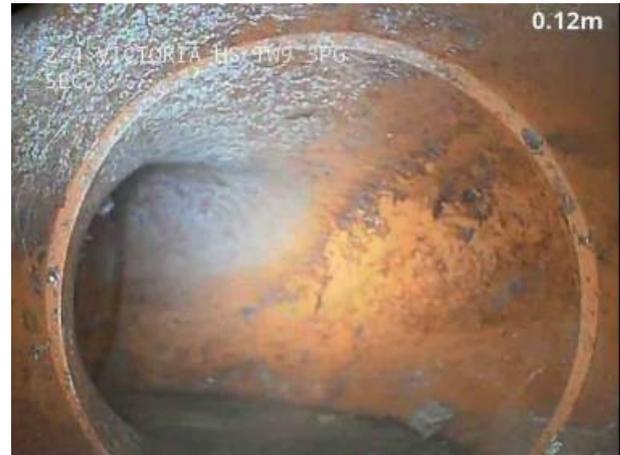
2, 00:00:07, 0.30 m
Line deviates left

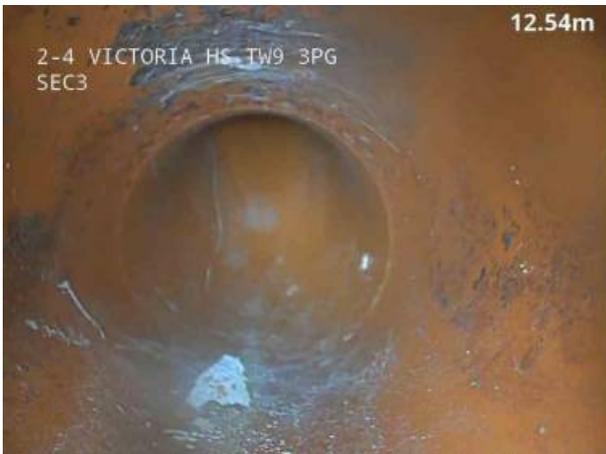
3, 00:01:54, 12.80 m
Line deviates up

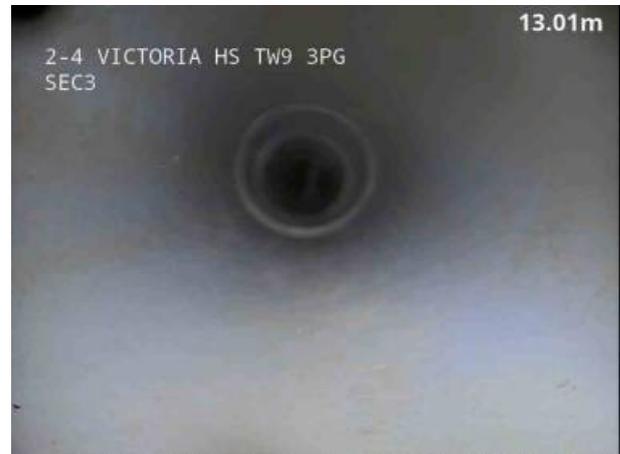
4, 00:02:03, 13.20 m
Finish node, manhole, reference: FP3

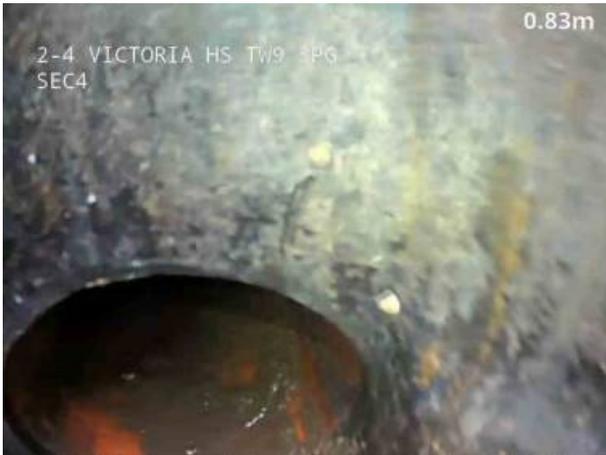
1, 00:00:00, 0.00 m
Start node, manhole, reference: MH5

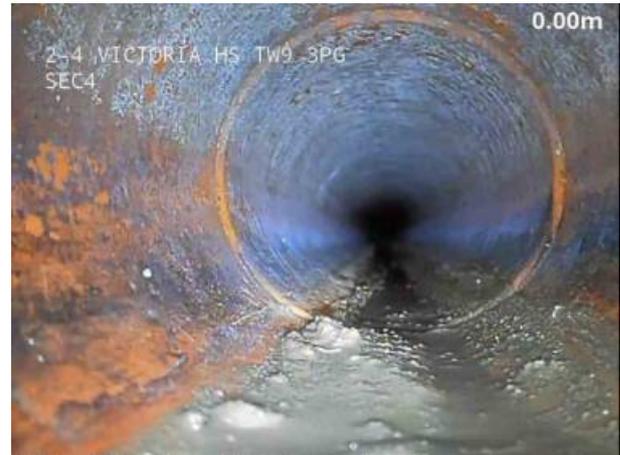
2, 00:00:01, 0.00 m
Water level, 0% of the vertical dimension

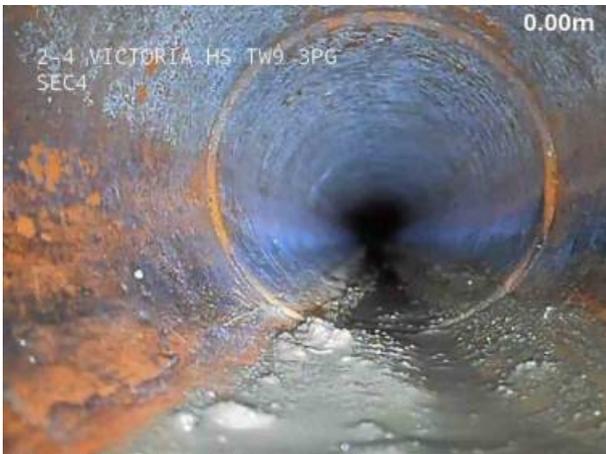
3, 00:00:01, 0.10 m
Settled deposits, fine, 5% cross-sectional area loss, start

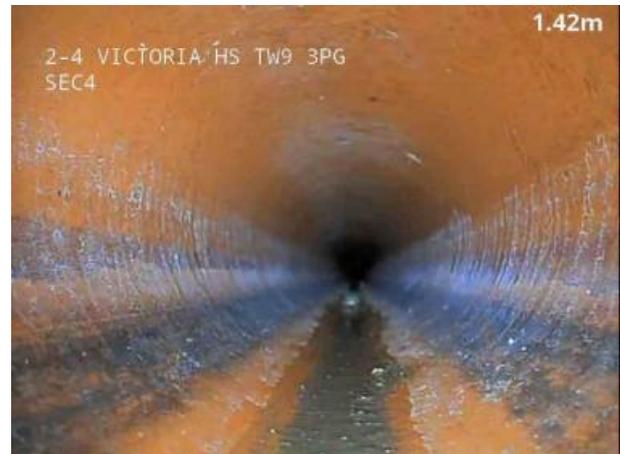
4, 00:00:13, 1.42 m
Settled deposits, fine, 5% cross-sectional area loss, finish

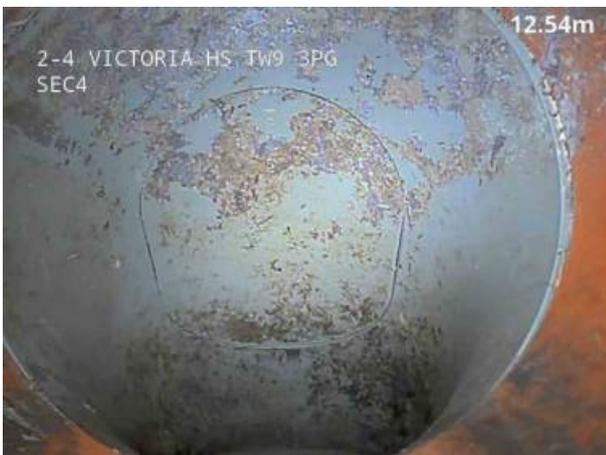
5, 00:00:59, 12.70 m
Line deviates down

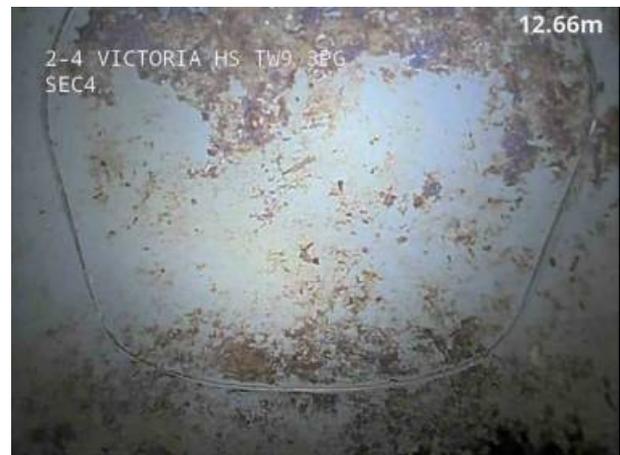
6, 00:01:23, 12.85 m
Finish node, manhole, reference: RE, Assumed into buried chamber, not located.

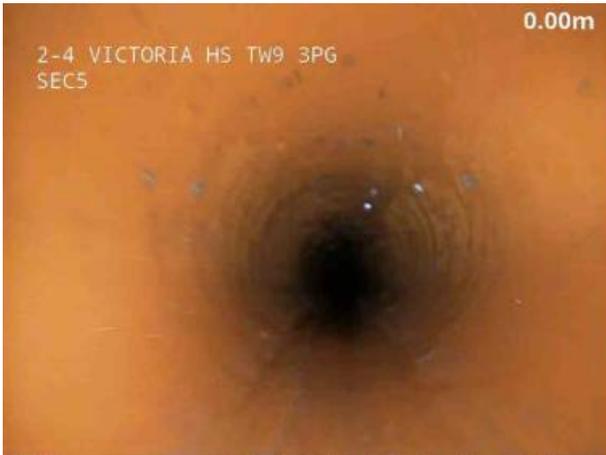
1, 00:00:59, 0.00 m
Water level, 0% of the vertical dimension

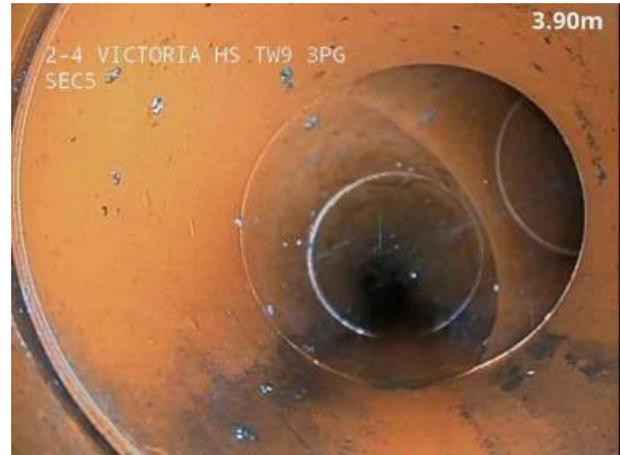
2, 00:01:25, 4.10 m
Junction at 2 o'clock, 100mm dia

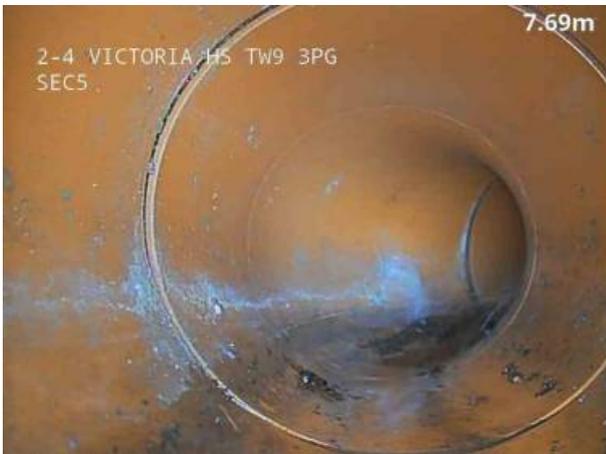
3, 00:01:45, 7.80 m
Line deviates right

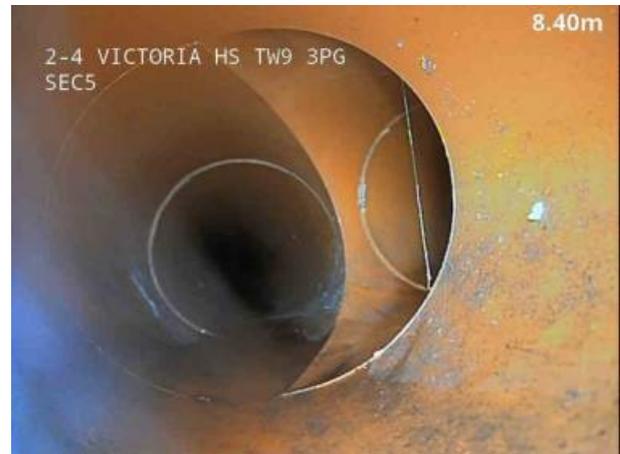
4, 00:01:57, 8.60 m
Junction at 3 o'clock, 100mm dia

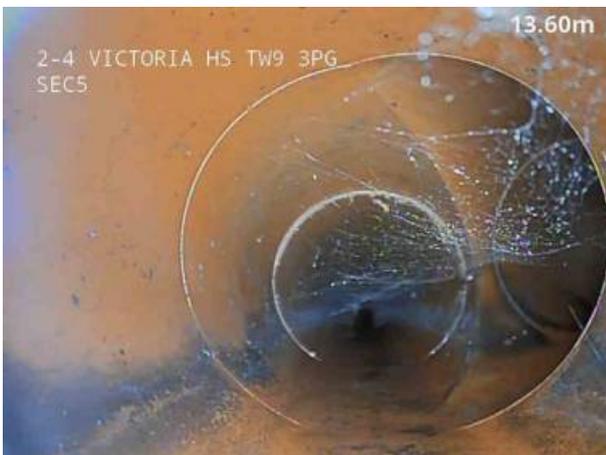
5, 00:02:21, 13.80 m
Junction at 3 o'clock, 100mm dia

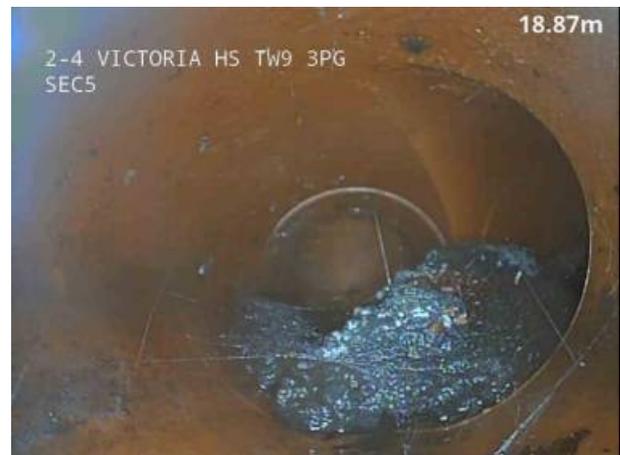
6, 00:02:54, 19.00 m
Junction at 3 o'clock, 100mm dia

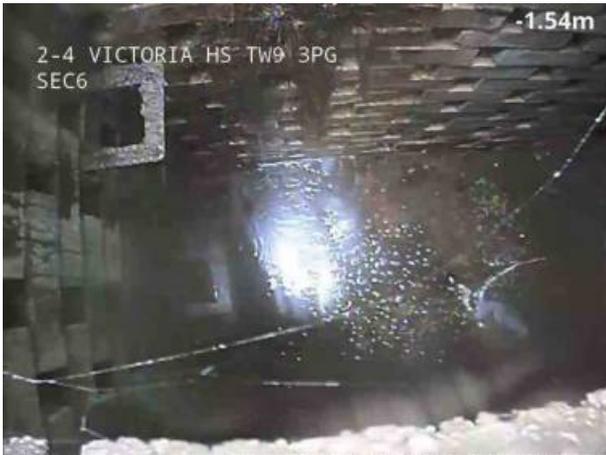
1, 00:00:00, 0.00 m
Start node, soakaway, reference: SK1

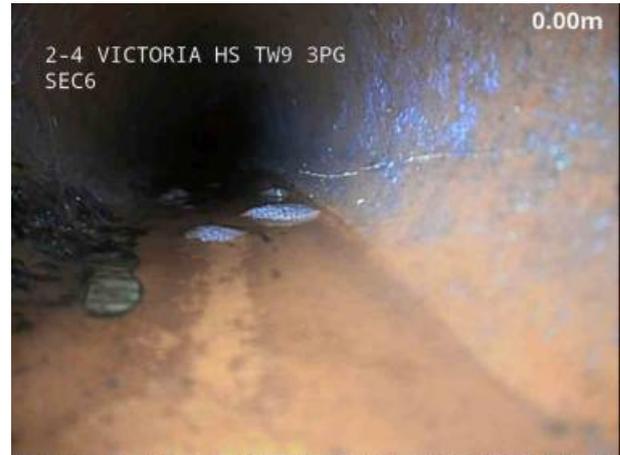
2, 00:00:02, 0.00 m
Water level, 10% of the vertical dimension

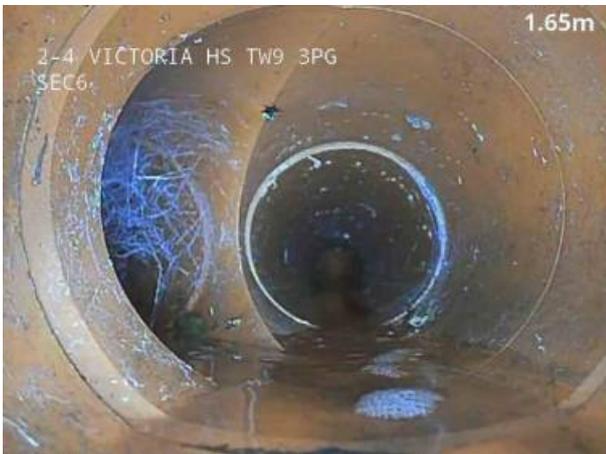
3, 00:00:26, 1.85 m
Junction at 9 o'clock, 100mm dia

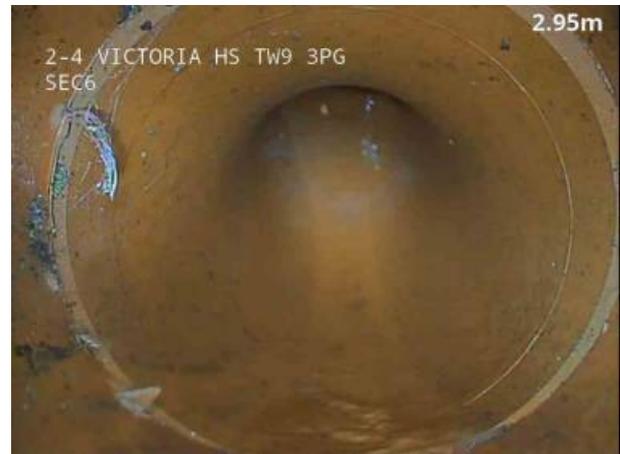
4, 00:00:42, 3.15 m
Line deviates up

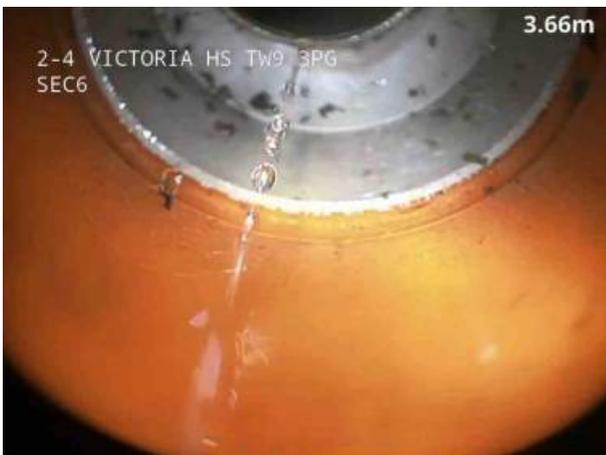
5, 00:00:58, 3.66 m
Finish node, manhole, reference: RWP18

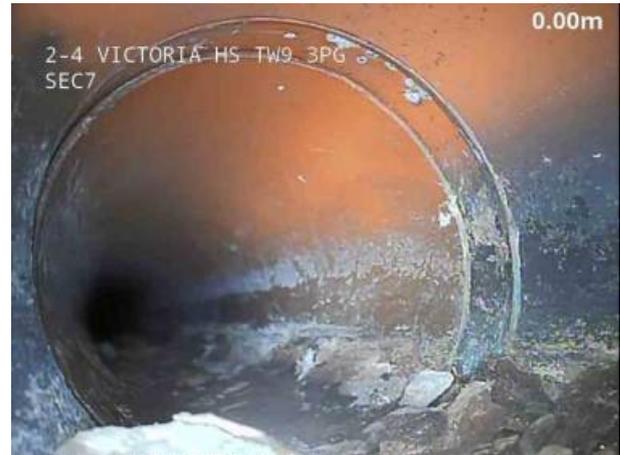
2, 00:00:01, 0.10 m
Settled deposits, coarse, 10% cross-sectional area loss, start

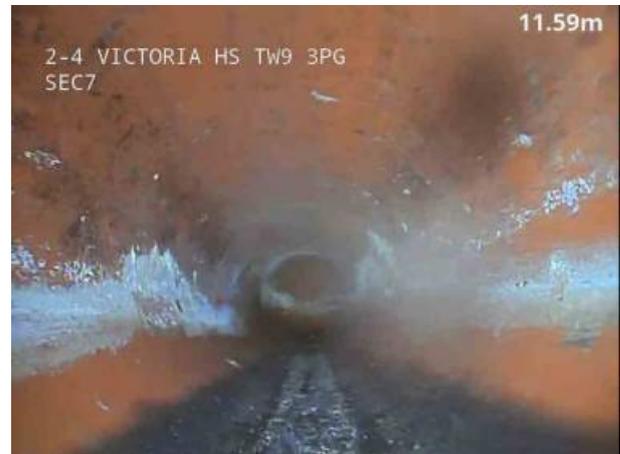
4, 00:01:10, 12.10 m
Settled deposits, coarse, 10% cross-sectional area loss, finish

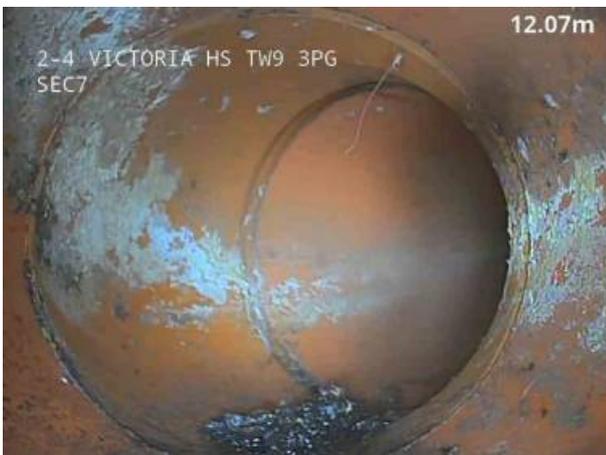
5, 00:00:56, 12.20 m
Line deviates right

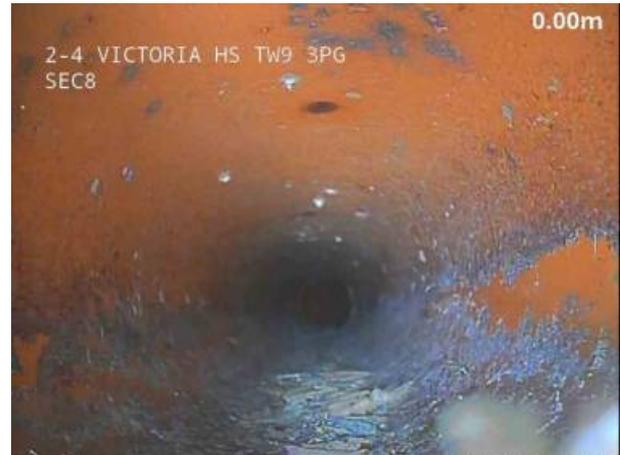
2, 00:00:00, 0.10 m
Settled deposits, coarse, 10% cross-sectional area loss, start

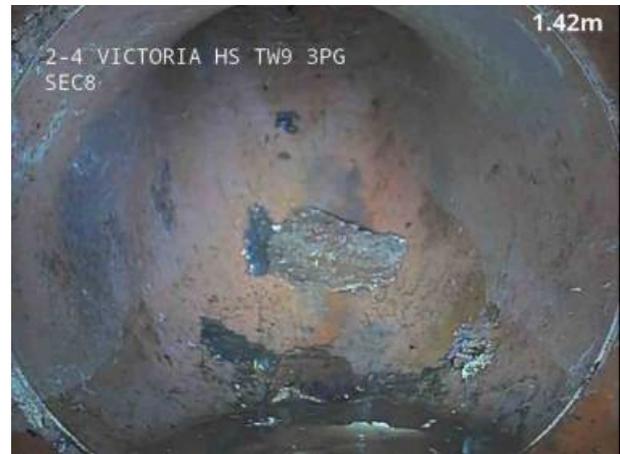
4, 00:00:55, 1.42 m
Settled deposits, coarse, 10% cross-sectional area loss, finish

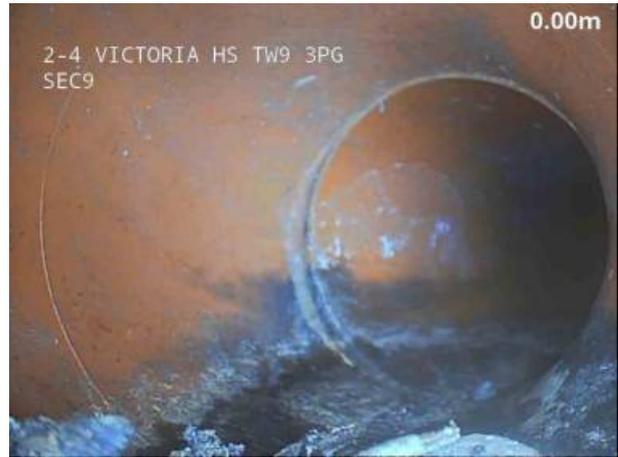
2, 00:00:04, 0.10 m
Settled deposits, coarse, 10% cross-sectional area loss, start

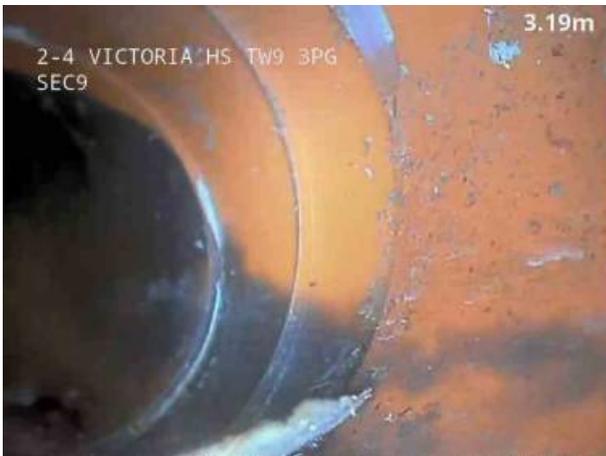
3, 00:00:34, 3.19 m
Settled deposits, coarse, 10% cross-sectional area loss, finish

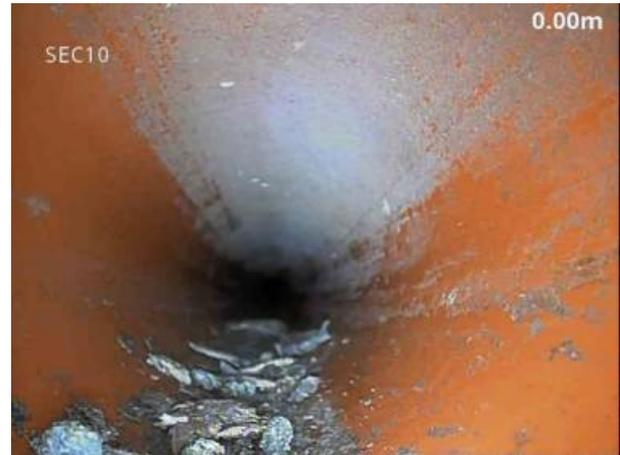
2, 00:00:01, 0.10 m
Settled deposits, coarse, 10% cross-sectional area loss, start

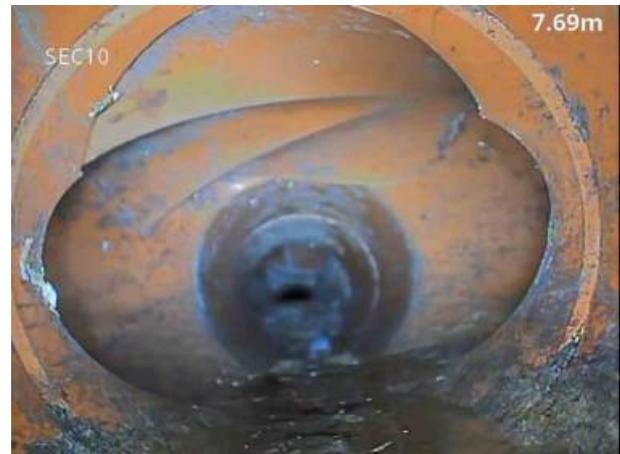
4, 00:00:32, 7.70 m
Settled deposits, coarse, 10% cross-sectional area loss, finish

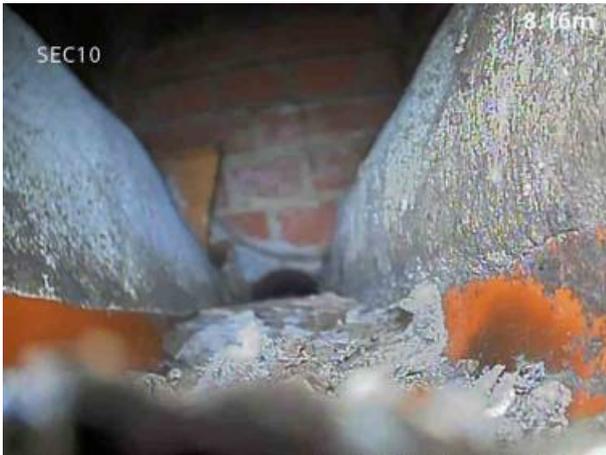
7, 00:00:46, 8.16 m
Settled deposits, coarse, 35% cross-sectional area loss, start

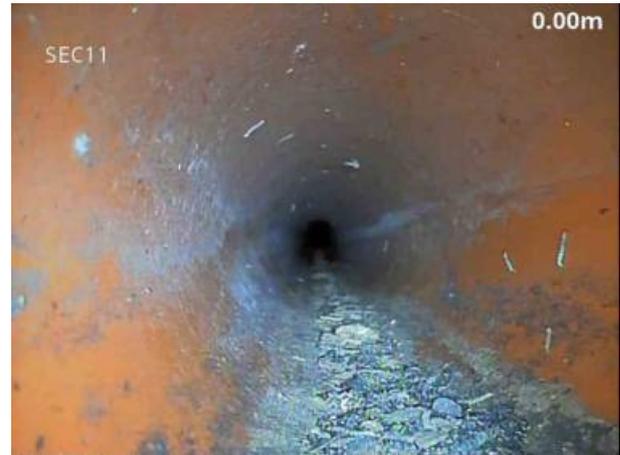
2, 00:00:03, 0.10 m
Settled deposits, coarse, 10% cross-sectional area loss, start

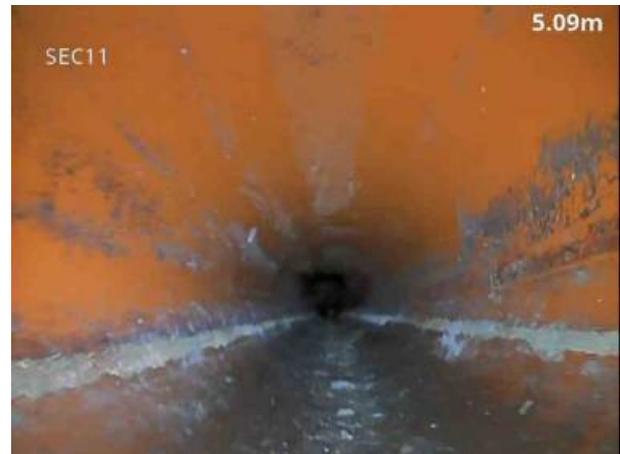
4, 00:00:22, 5.09 m
Settled deposits, coarse, 10% cross-sectional area loss, finish

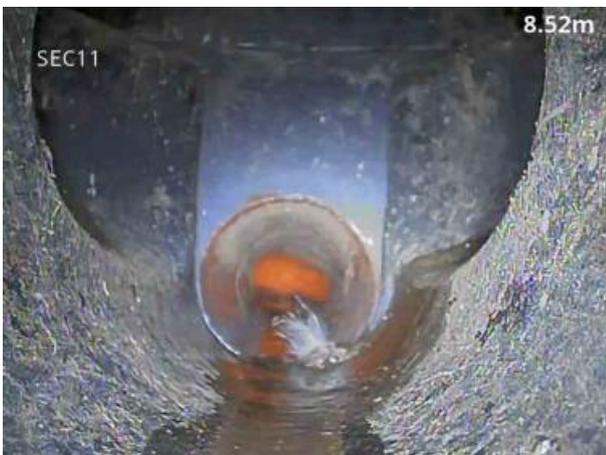
5, 00:00:37, 8.52 m
Finish node, manhole, reference: MH2

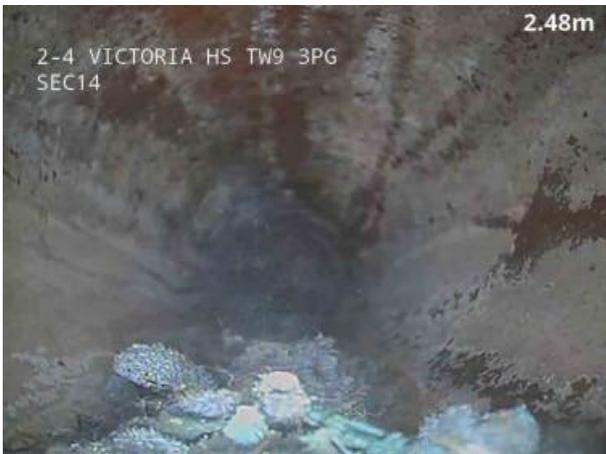
3, 00:00:17, 2.48 m
Settled deposits, coarse, 15% cross-sectional area loss, start

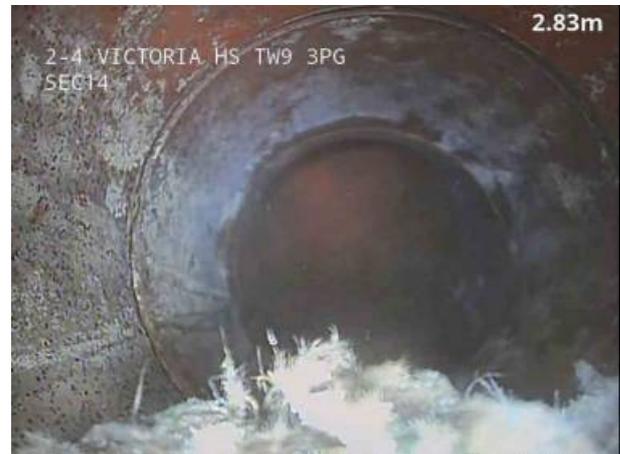
4, 00:00:19, 2.84 m
Settled deposits, coarse, 20% cross-sectional area loss, change

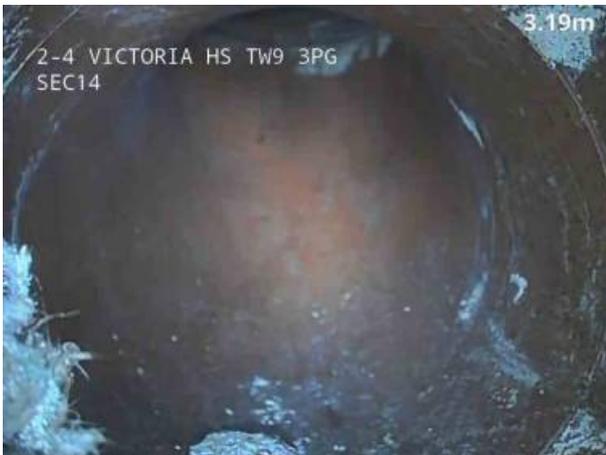
5, 00:00:28, 3.20 m
Settled deposits, coarse, 20% cross-sectional area loss, finish

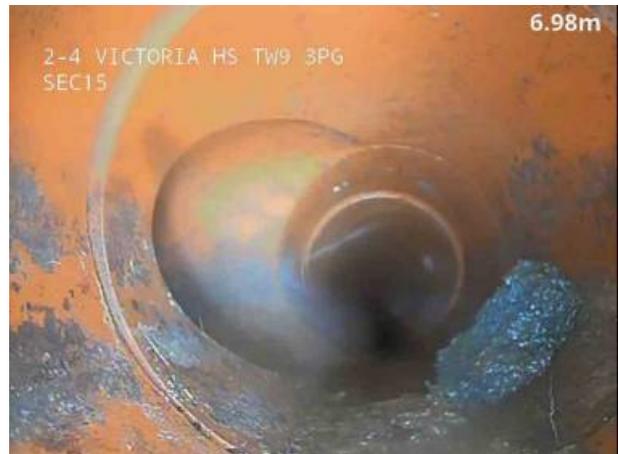
4, 00:00:49, 7.15 m
Settled deposits, coarse, 5% cross-sectional area loss

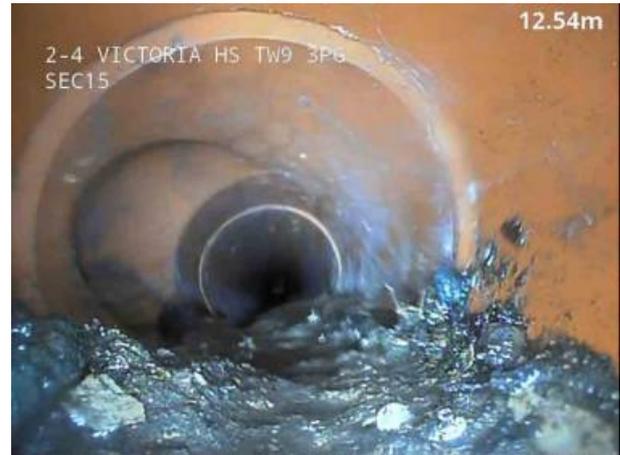
8, 00:01:48, 12.54 m
Settled deposits, fine, 35% cross-sectional area loss, change

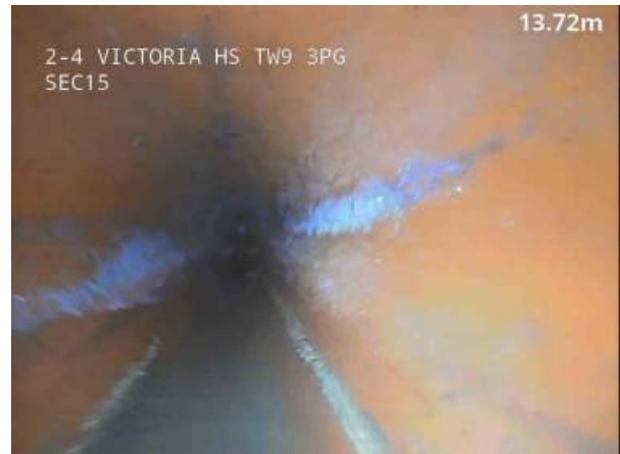
10, 00:01:57, 13.72 m
Settled deposits, fine, 35% cross-sectional area loss, finish

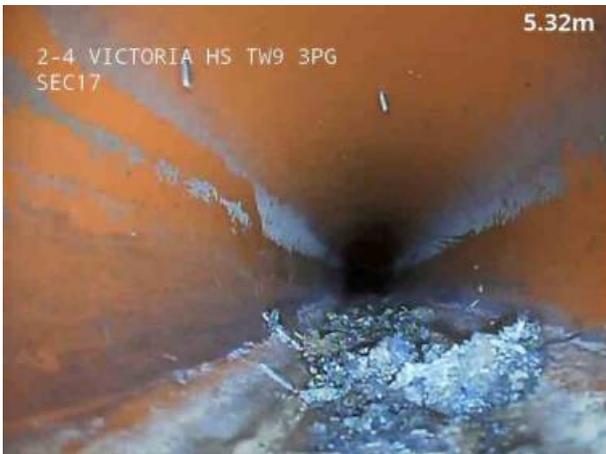
3, 00:00:33, 5.32 m
Settled deposits, fine, 10% cross-sectional area loss, start

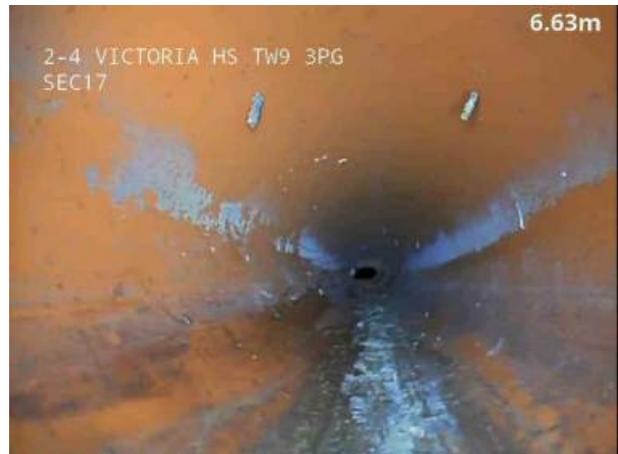
4, 00:00:38, 6.63 m
Settled deposits, fine, 10% cross-sectional area loss, finish

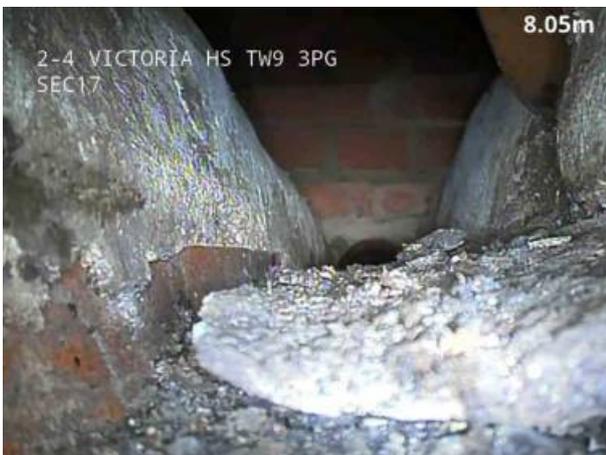
5, 00:00:50, 8.05 m
Settled deposits, fine, 60% cross-sectional area loss

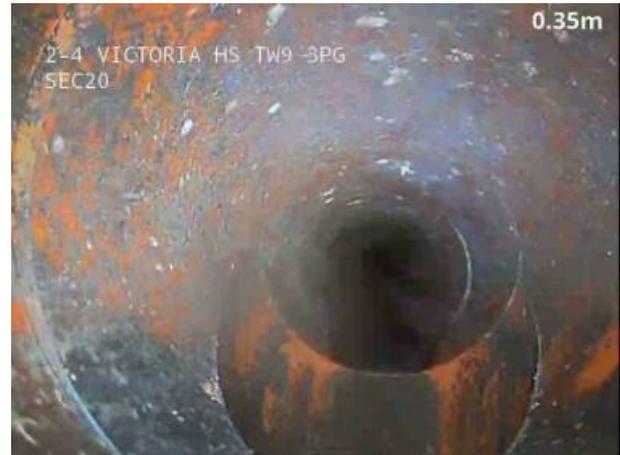
2, 00:00:05, 0.45 m
Line deviates down, Backdrop

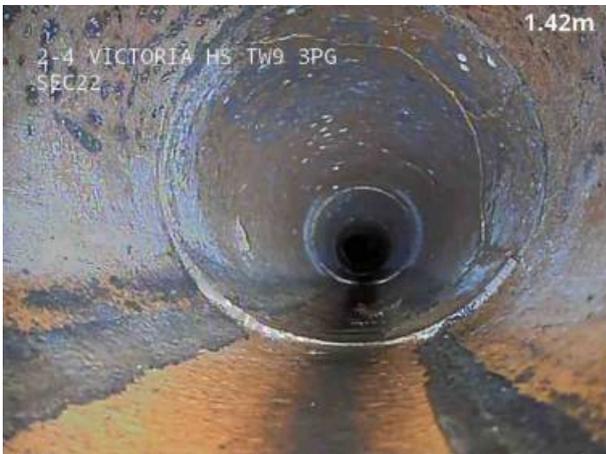
<table><tr> <td style="width: 10%; text-align: right;">0.00</td> <td style="width: 10%;">MH</td> <td style="width: 40%;">Start node, manhole, reference: MH1: Through Interceptor rodding eye</td> <td style="width: 10%;">00:00:00</td> <td></td> <td></td> <td></td> </tr><tr> <td style="text-align: right;">1.70</td> <td>FMJ</td> <td>Fractures, multiple at joint from 10 o'clock to 6 o'clock</td> <td>00:00:43</td> <td>3</td> <td></td> <td>4 / 2</td> </tr></table>

3, 00:00:43, 1.70 m
Fractures, multiple at joint from 10 o'clock to 6 o'clock

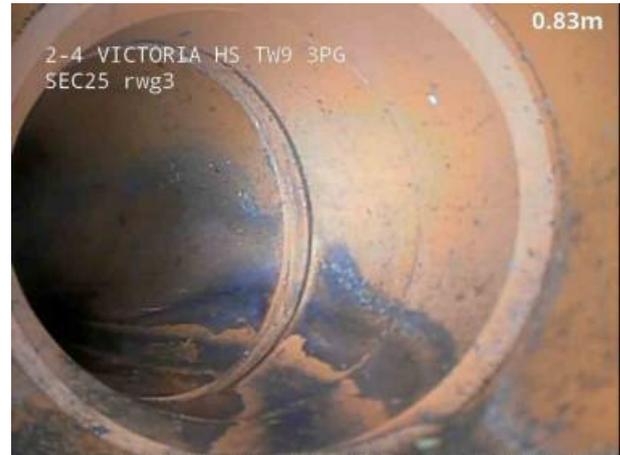
2, 00:00:28, 1.00 m
Line deviates left

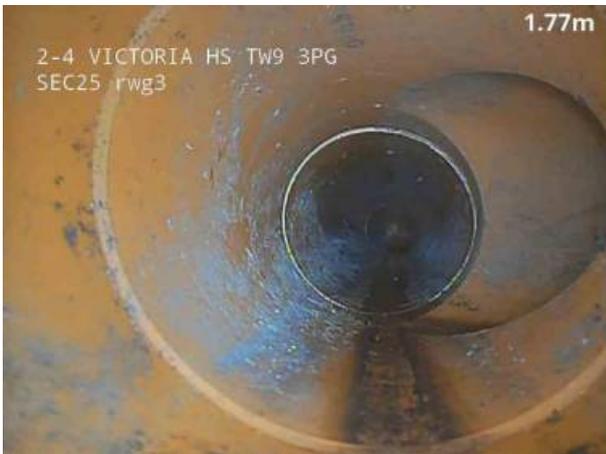
3, 00:00:37, 1.90 m
Junction at 3 o'clock, 100mm dia

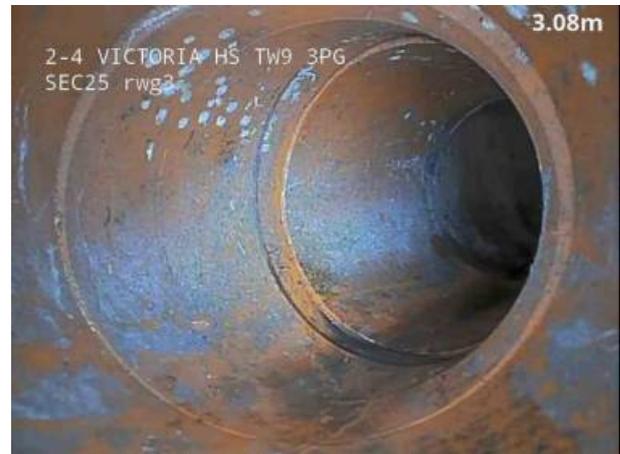
4, 00:00:44, 3.20 m
Line deviates right

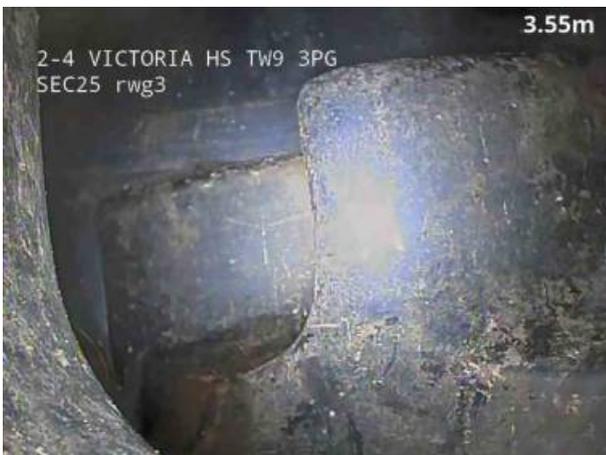
5, 00:00:51, 3.50 m
Finish node, manhole, reference: MH2
